# Report on the Jagersfontein Tailings Disaster

Bench Marks Foundation  
October 2022

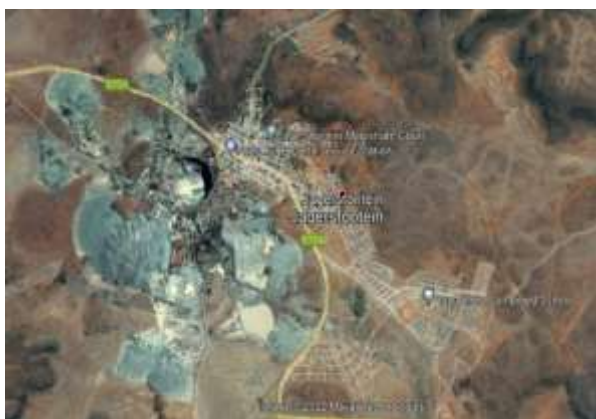
Photo 1 Tailings in 2005

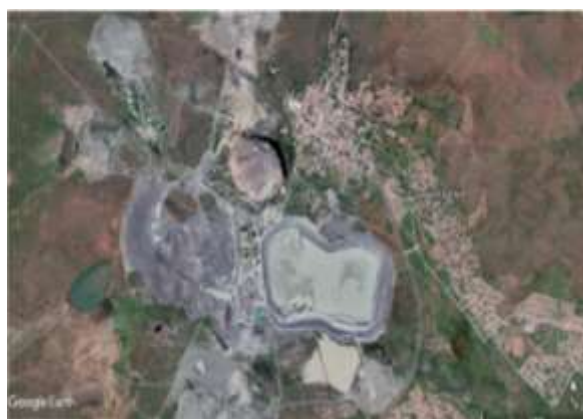
Photo 2 Tailings in 2022

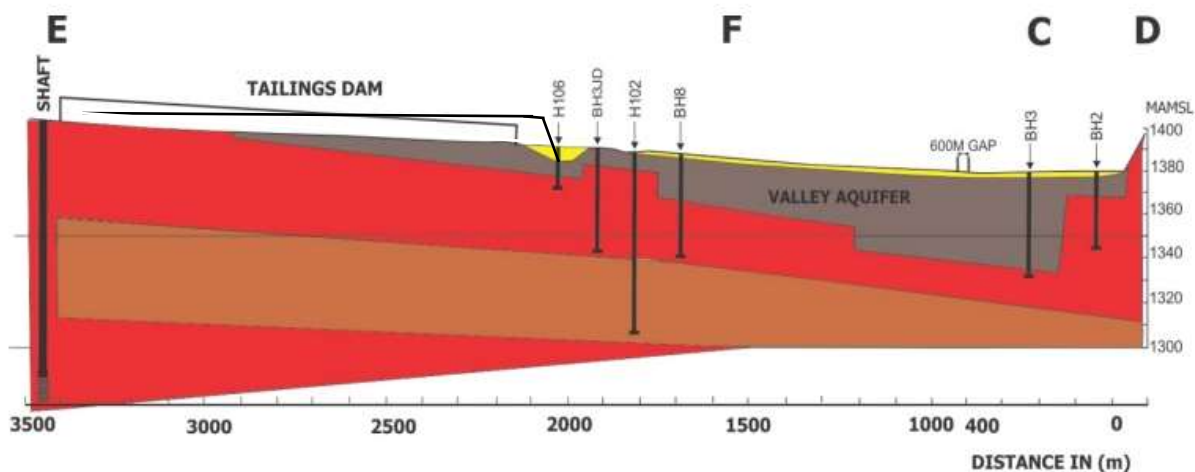
Figure 3 South-west to north-east cross-section of the Jagersfontein tailings (Adapted from a desk study by Colliston, 2021)

Figure 3 shows that the Jagersfontein tailings lies directly on top of the shallow Valley aquifer. The aquifer and water table surfaces are exactly underneath the highest and therefore most stressed/pressured northern retaining wall of the tailings. It was thus not a matter of if the tailings would break, but of when.

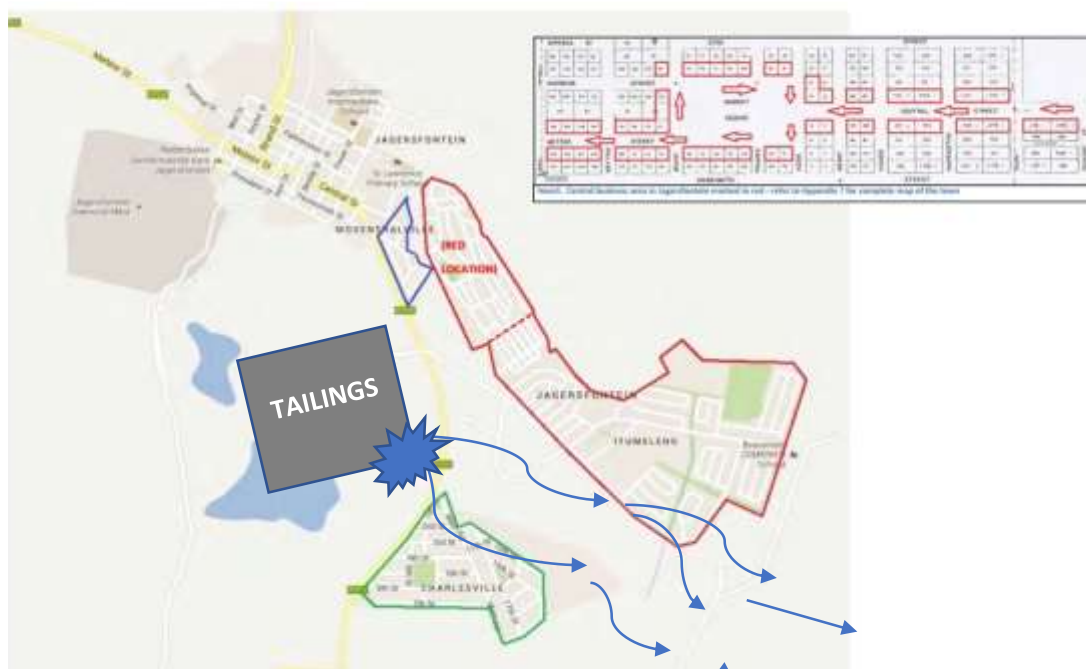
Figure 4 Breach and direction of the flow of the slurry on the impacted sections of Charlesville and Itumeleng (Adapted from Philip, 2014)

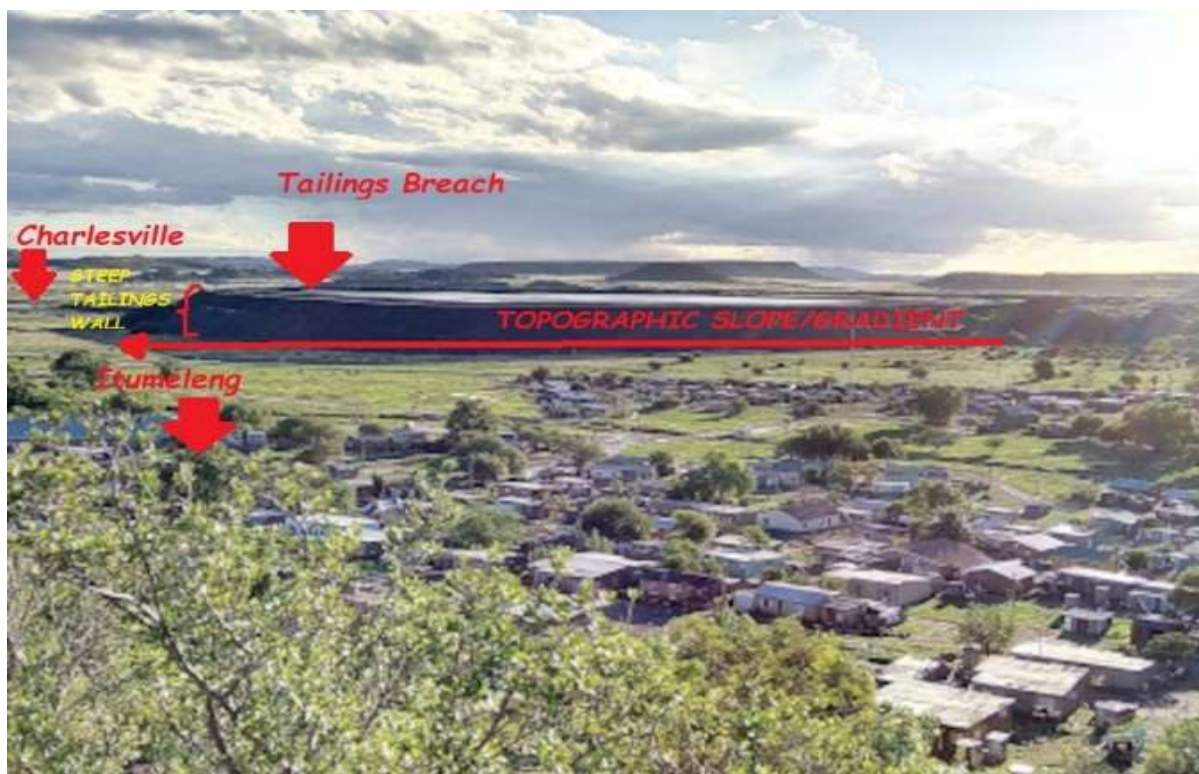
The Jagersfontein tailings, as shown in Photo 3, are constructed on a slope. The speed and power of the surge were in part determined by the slope. Typically, of apartheid urban planning and space allocation, the former white town of Jagersfontein was constructed above the mining operation and its tailings. The black townships of Itumeleng and Charlesville were constructed downhill and downwind of the tailings below the steepest gradients of the tailings on its south-eastern and north-western corners. The south-eastern corner of the tailings dam broke and rushed down the valley, sweeping away parts of Charlesville. Six homes were wiped away and numerous others damaged. Casualties and injuries happened before the surge turned up into the opposite side of the valley hitting parts of Itumeleng and causing massive damage to homes there. Photo 3 shows the slope, the gradient of the tailings and the location of the two townships from a vantage point to the north.

Photo 3 Slope, gradient of tailings and location of the two townships from a vantage point to the north  
(Adapted from Google Maps)

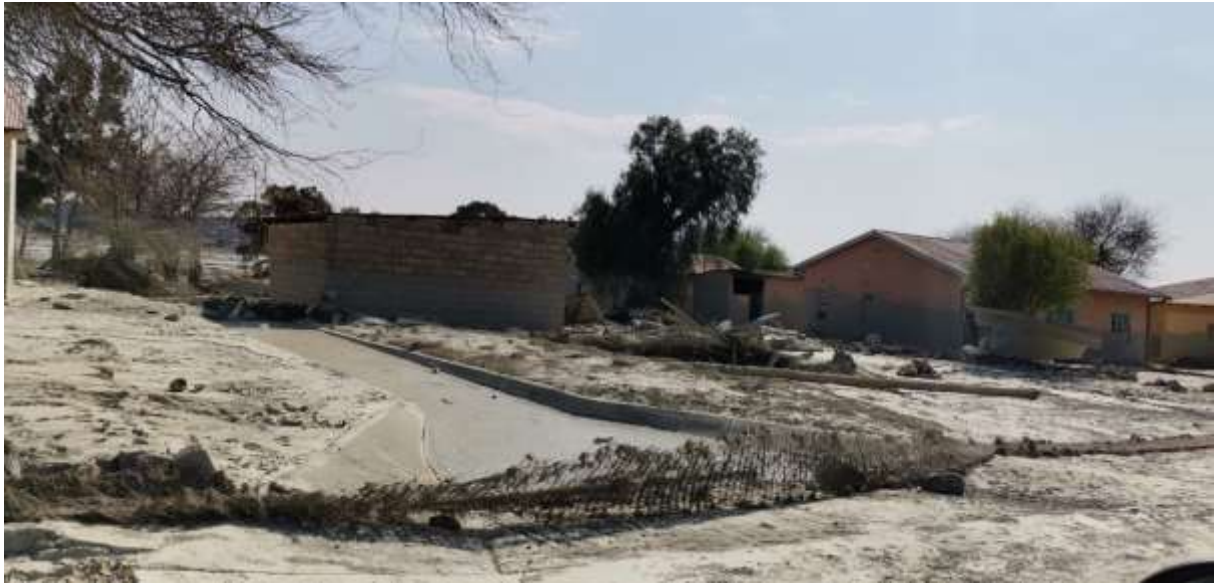
*Photo 4 Only thing left of the houses in the front of the photo are their foundations, Charlesville (Photo credit Brown Motsau and David van Wyk)*

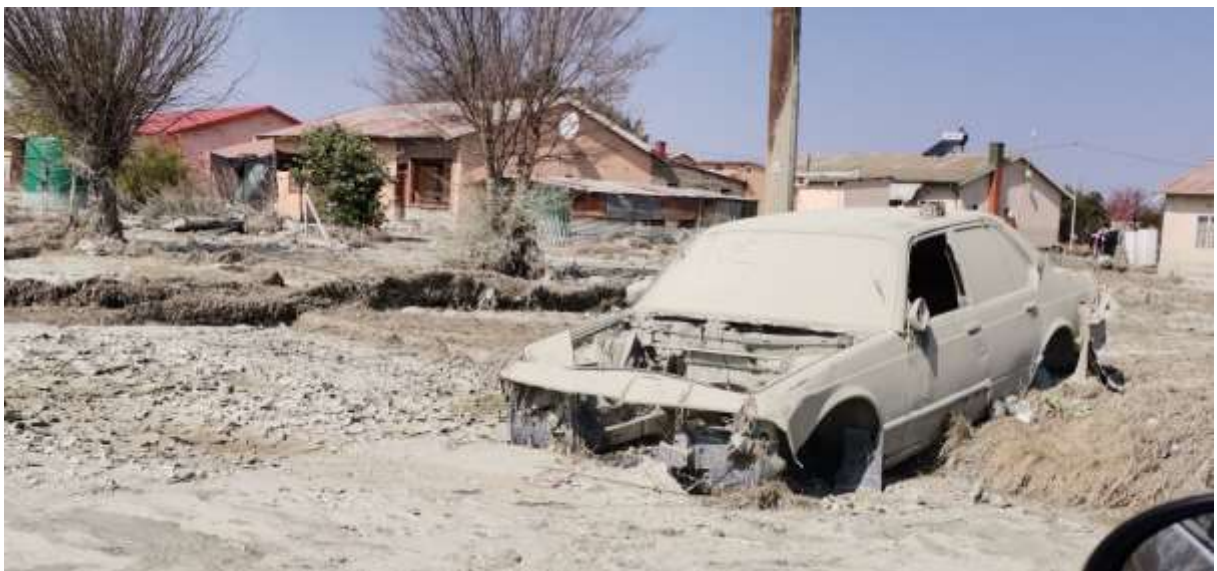
*Photo 5 Many of the low-income residents of Charlesville lost cars, furniture, homes and loved ones (Photo credit Brown Motsau and David van Wyk)*

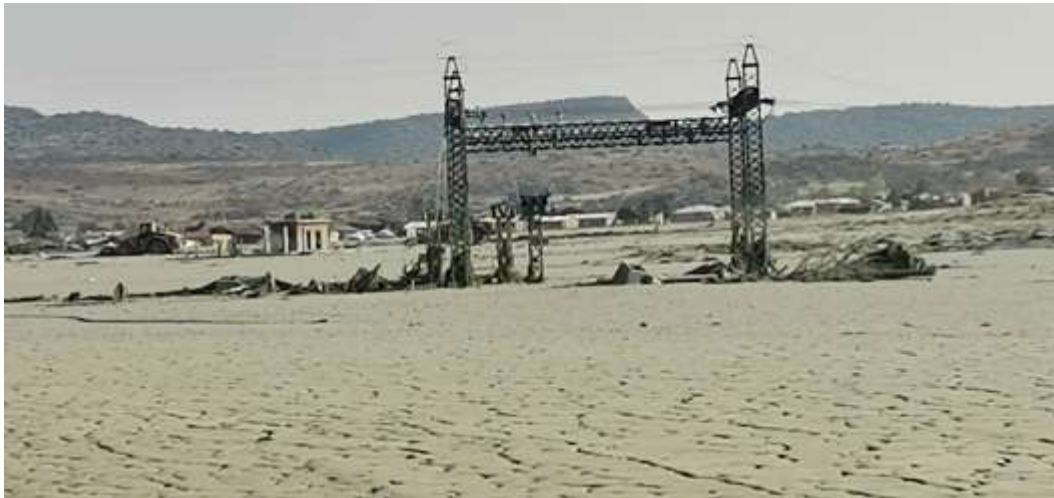
*Photo 6 Remains of the electricity substation of Jagersfontein (Photo credit David van Wyk and Brown Motsau)*

When the tailings broke, it swept away the electricity substation feeding the town, swamped the sewage works and halted water, apart from sweeping across the R704 in three separate places. Typical of apartheid urban planning and space allocation, the former white town of Jagersfontein was constructed above the mining operation and its tailings, while the black townships of Itumeleng and Charlesville were constructed downhill and downwind of the tailings below the steepest gradients of the tailings on its north-eastern and north-western corners.

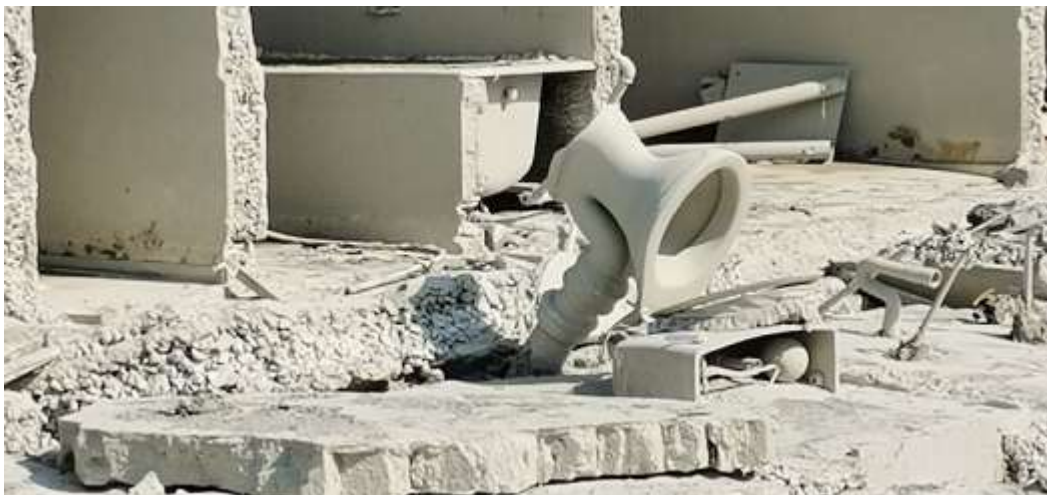
*Photo 7 Sewage infrastructure in some private homes and in the municipal infrastructure was swept away (Photo credit Brown Motsau and David van Wyk)*

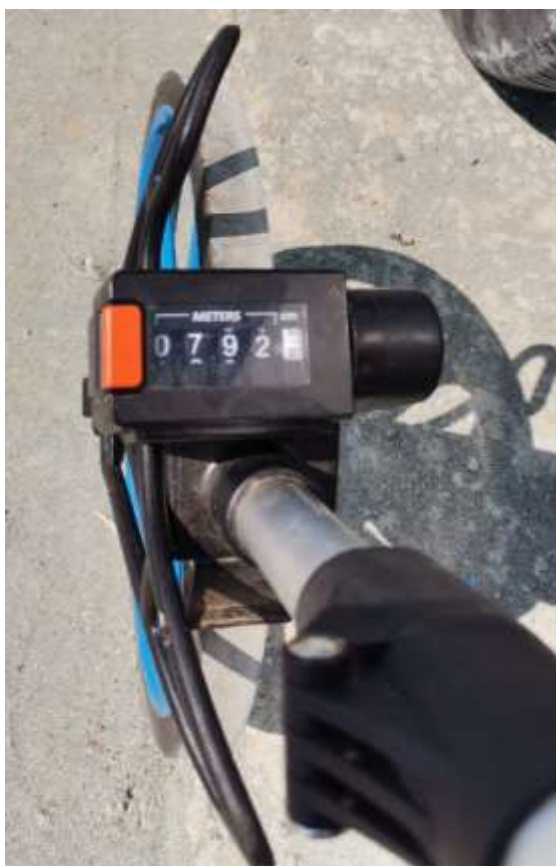
Photo 8 Slurry swept 792 m wide across the R704  
(Photo credit: Brown Motsau and David van Wyk)

The offices of the South African Social Security Agency (SASSA) in Charlesville came close to disaster, as did some schools in Itumeleng. The R704 provincial road linking Jagersfontein to Bloemfontein is below the tailings and less than 100 m from it. The nearest houses in Charlesville are less than 250 m away from it. The Bench Marks Foundation has long called for exclusion zones of between 500 and 1 500 m around tailings.

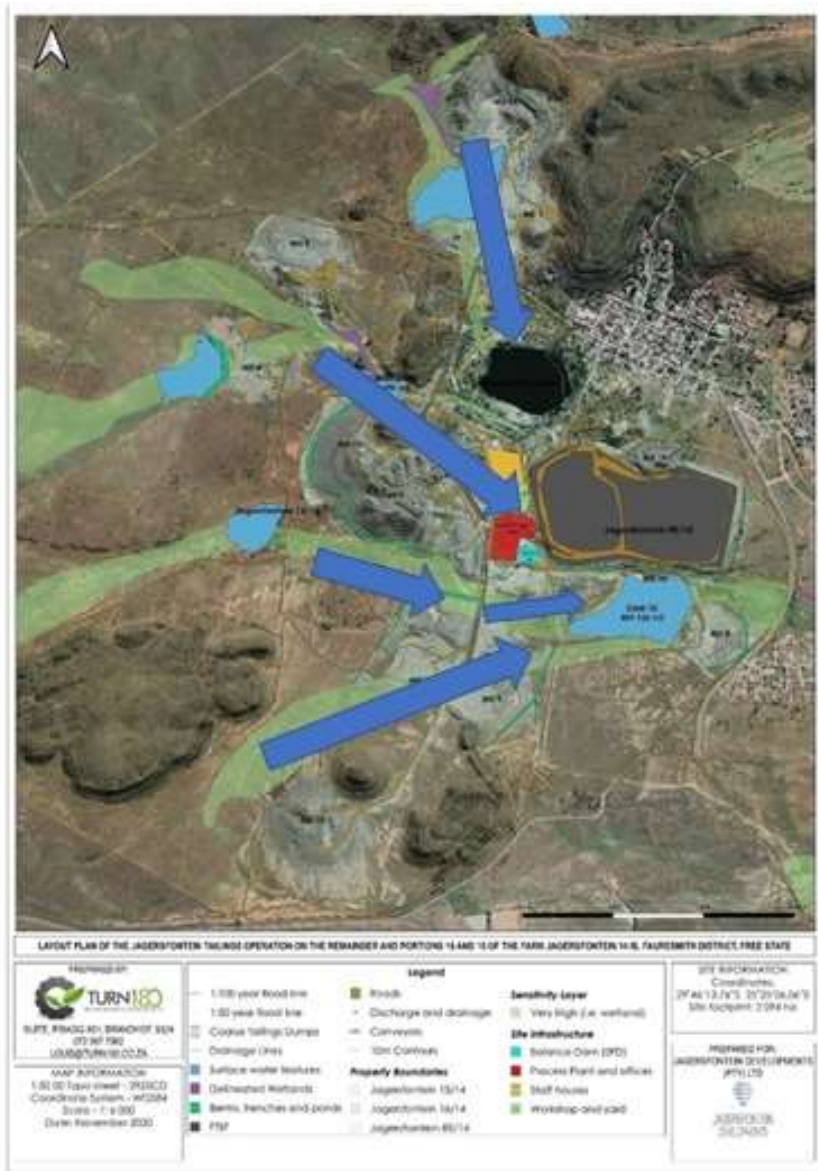
Figure 5 shows that the tailings dam was built on top of a shallow aquifer. Several catchments also flowed in directly behind the tailings, increasing its liquidity and the pressure on its northern wall above the communities of Charlesville and Itumeleng.

Figure 5 Blue arrows showing catchments flowing towards and converging exactly where the tailings are located (Turn 180)

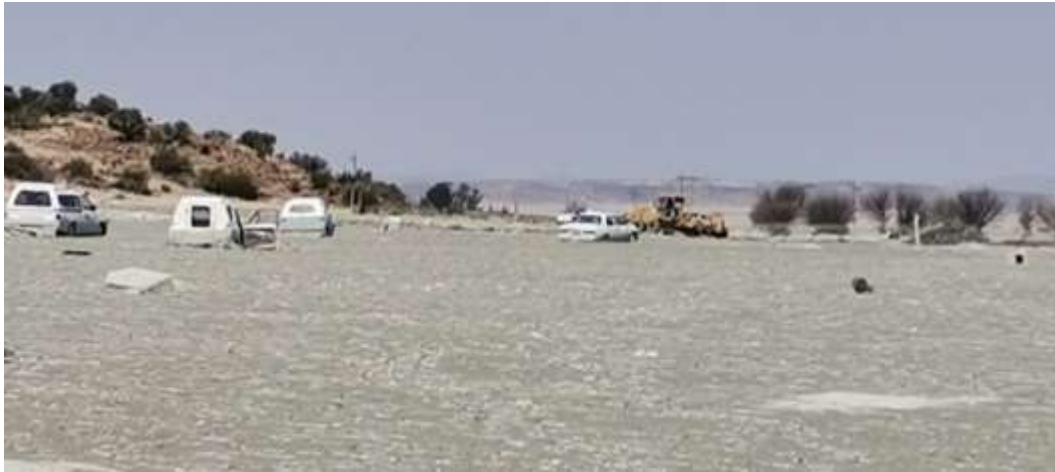
*Photo 9 Cars swept away by the tailings surge as it edged through Itumeleng  
(Photo credit Brown Motsau and David van Wyk)*

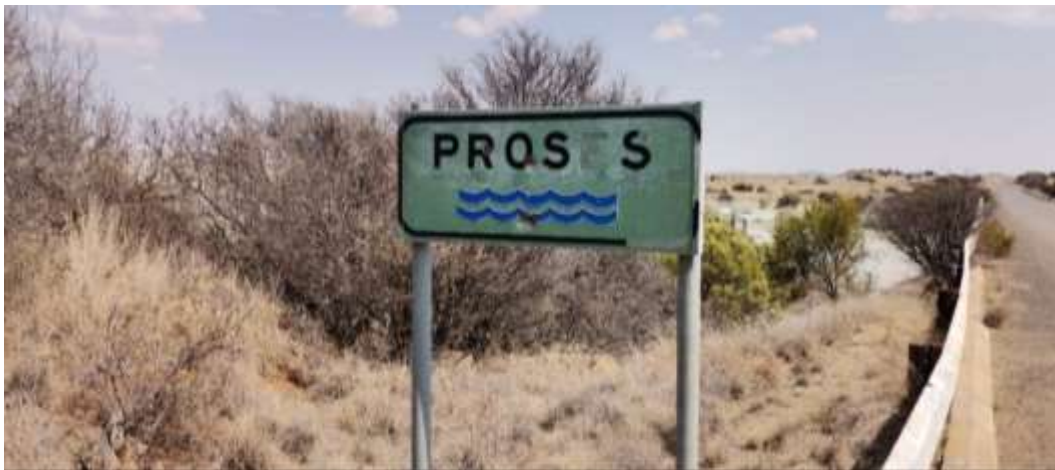
The slurry surge washed downstream and entirely drowned the Vlakfontein farm. The media reported that the farmer lost 90% of his sheep. The damage to his grazing is irreparable. The surge eventually ended up in the Proses River, ten kilometres downstream from Jagersfontein. The Proses River feeds into the Vaal River before it merges with the Xhariep River. Locals reported dead fish along the banks of the river.

*Photo 10 Heavily impacted Proses River, some 10 km out of town  
(Photo credit Brown Motsau and David van Wyk)*

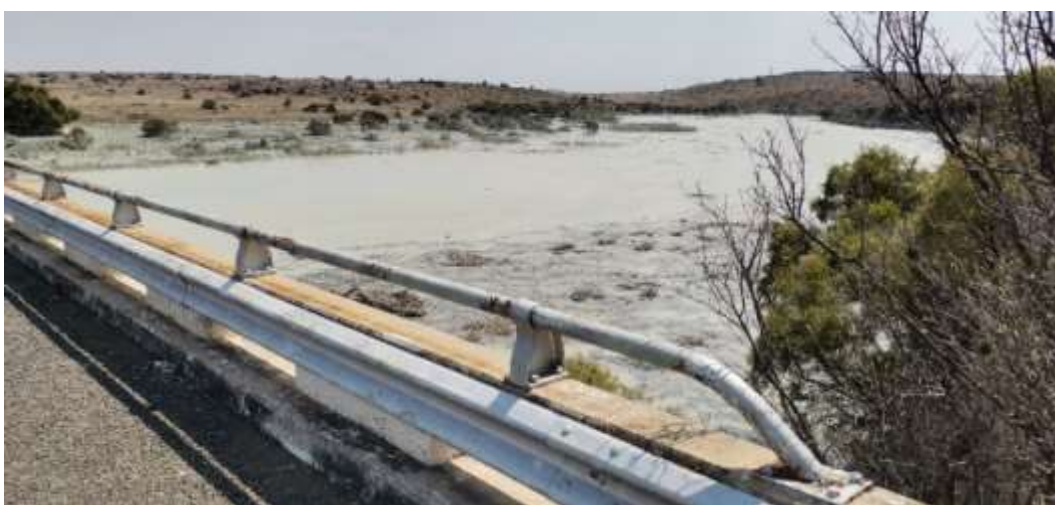
*Photo 11 Proses River, the fish leapt out onto the banks to escape the tailings mud  
(Photo Credit David van Wyk and Brown Motsau)*

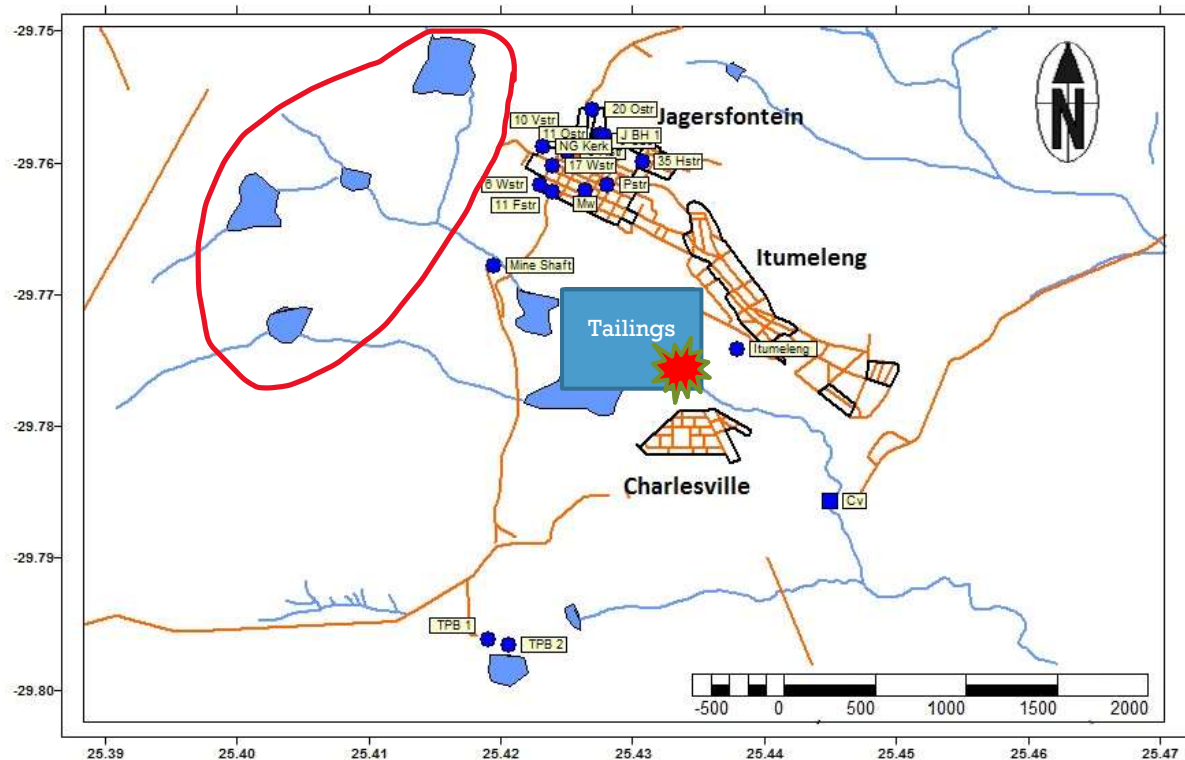
Figure 6 River catchments converged where the tailings is located.

*Note the upstream dams from the tailings indicating very poor planning, environmental impact assessment and environmental management plan by the mine, and absolute failure by the regulator (Adapted from Hoon, 2013)*
