# Report on the Jagersfontein Tailings Disaster

Research Department

Bench Marks Foundation  
October 2022

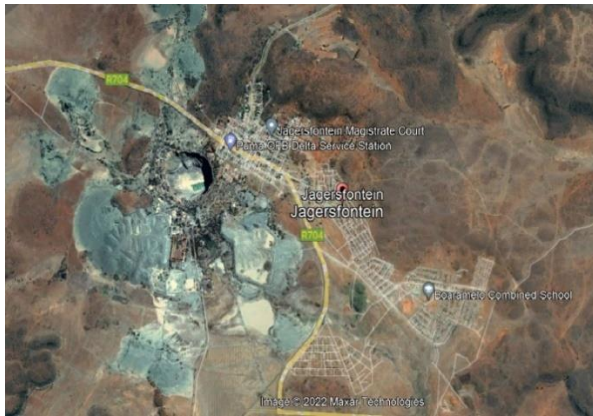
Photo 1 Tailings in 2005

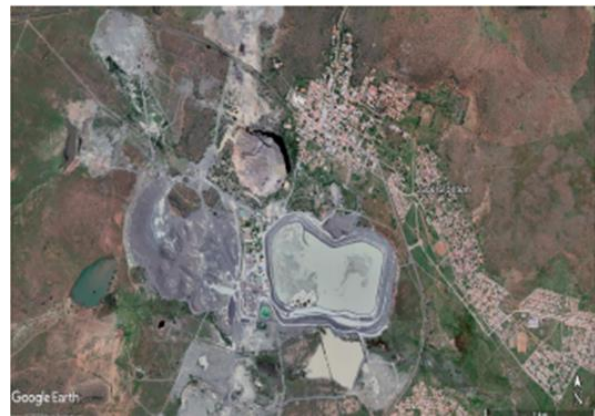
Photo 2 Tailings in 2022

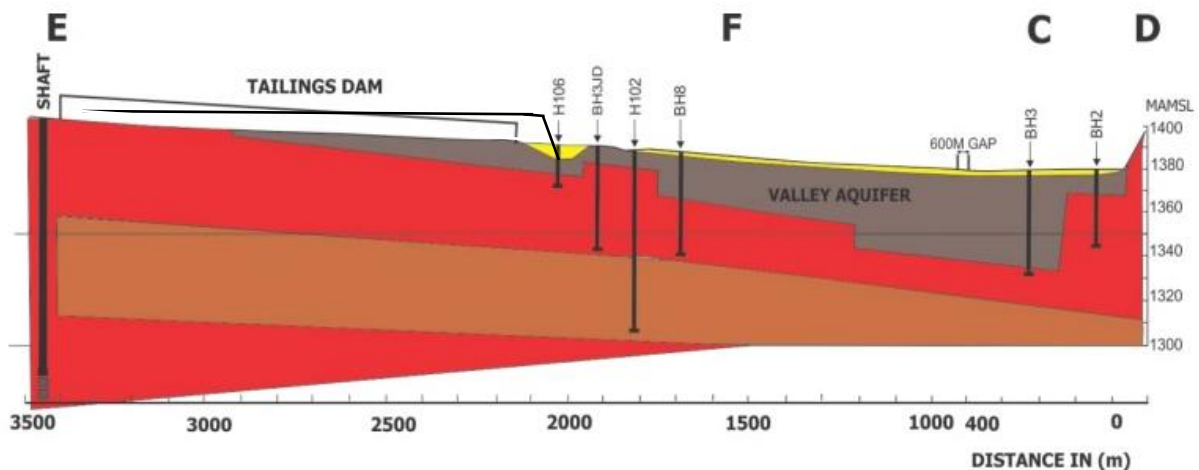
Figure 3 South-west to north-east cross-section of the Jagersfontein tailings (Adapted from a desk study by Colliston, 2021)

Figure 3 shows that the Jagersfontein tailings lies directly on top of the shallow Valley aquifer. The aquifer and water table surfaces are exactly underneath the highest and therefore most stressed/pressured northern retaining wall of the tailings. It was thus not a matter of if the tailings would break, but of when.

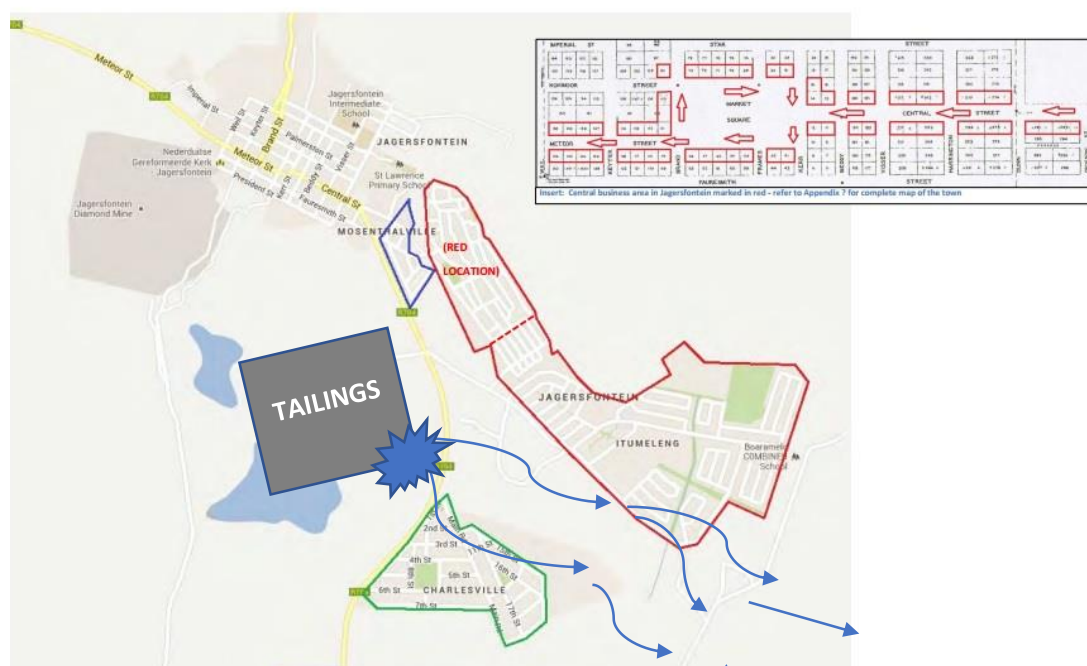
Figure 4 Breach and direction of the flow of the slurry on the impacted sections of Charlesville and Itumeleng (Adapted from Philip, 2014)

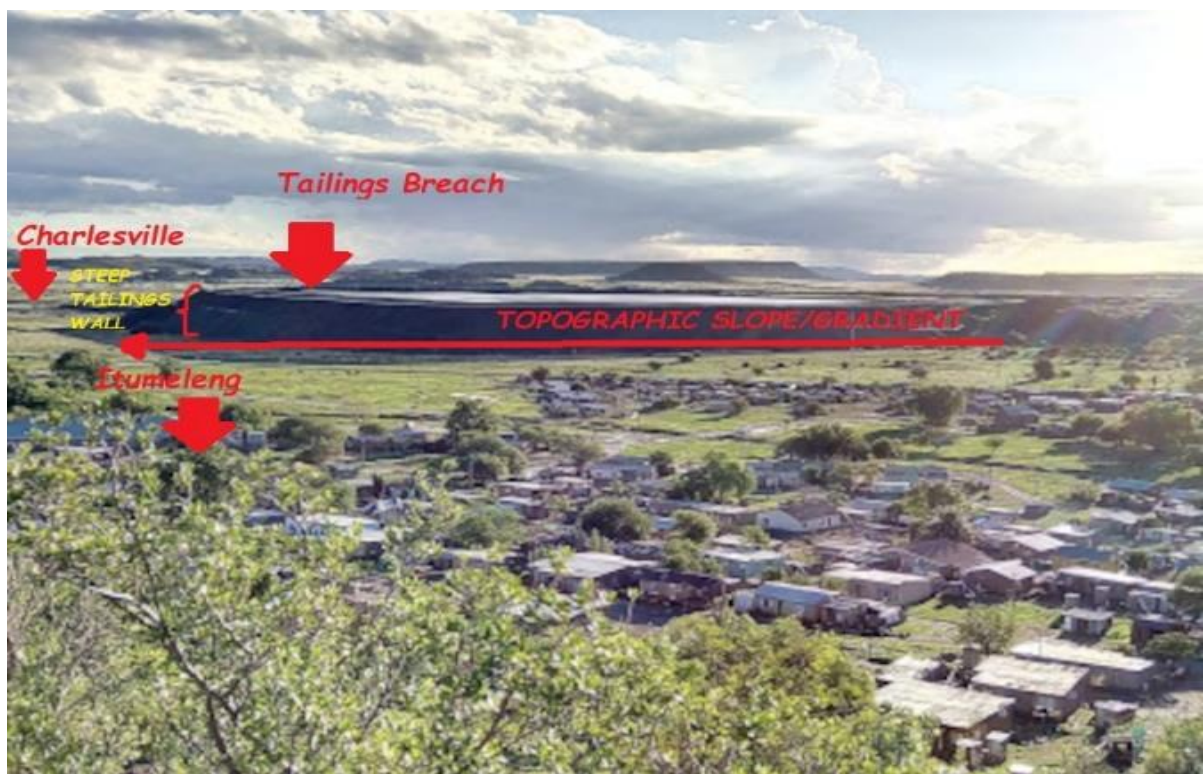
The Jagersfontein tailings, as shown in Photo 3, are constructed on a slope. The speed and power of the surge were in part determined by the slope. Typically, of apartheid urban planning and space allocation, the former white town of Jagersfontein was constructed above the mining operation and its tailings. The black townships of Itumeleng and Charlesville were constructed downhill and downwind of the tailings below the steepest gradients of the tailings on its south-eastern and north-western corners. The south-eastern corner of the tailings dam broke and rushed down the valley, sweeping away parts of Charlesville. Six homes were wiped away and numerous others damaged. Casualties and injuries happened before the surge turned up into the opposite side of the valley hitting parts of Itumeleng and causing massive damage to homes there. Photo 3 shows the slope, the gradient of the tailings and the location of the two townships from a vantage point to the north.

Photo 3 Slope, gradient of tailings and location of the two townships from a vantage point to the north  
(Adapted from Google Maps)

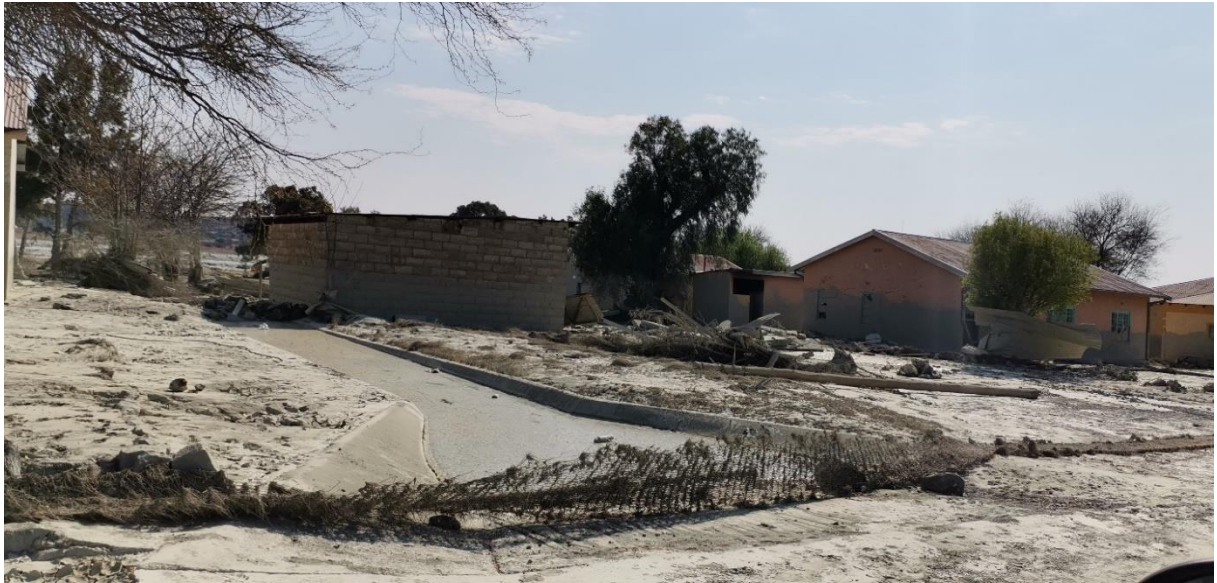
*Photo 4 Only thing left of the houses in the front of the photo are their foundations, Charlesville (Photo credit Brown Motsau and David van Wyk)*

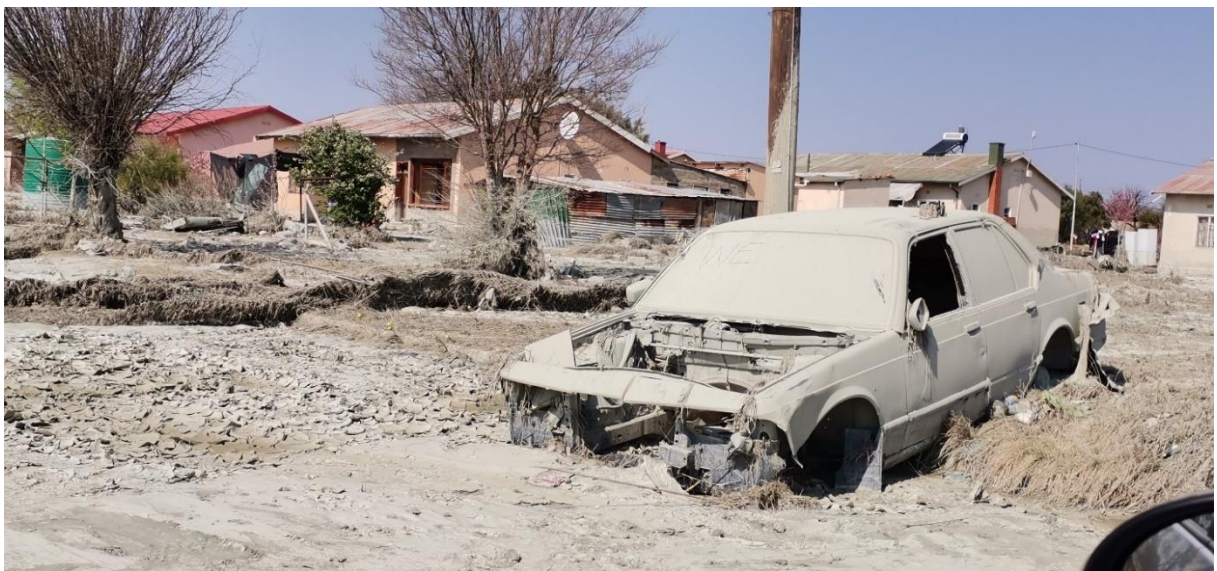
*Photo 5 Many of the low-income residents of Charlesville lost cars, furniture, homes and loved ones (Photo credit Brown Motsau and David van Wyk)*

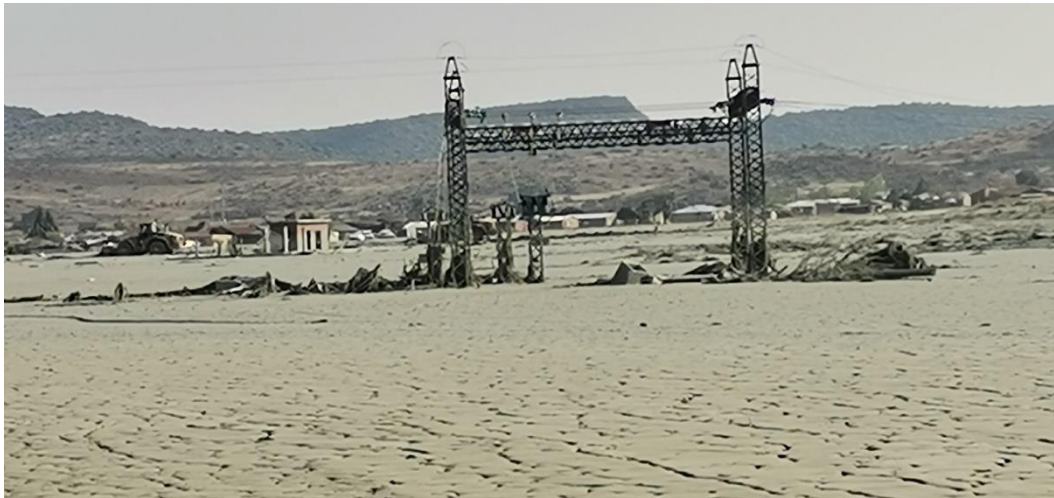
*Photo 6 Remains of the electricity substation of Jagersfontein (Photo credit David van Wyk and Brown Motsau)*

When the tailings broke, it swept away the electricity substation feeding the town, swamped the sewage works and halted water, apart from sweeping across the R704 in three separate places. Typical of apartheid urban planning and space allocation, the former white town of Jagersfontein was constructed above the mining operation and its tailings, while the black townships of Itumeleng and Charlesville were constructed downhill and downwind of the tailings below the steepest gradients of the tailings on its north-eastern and north-western corners.

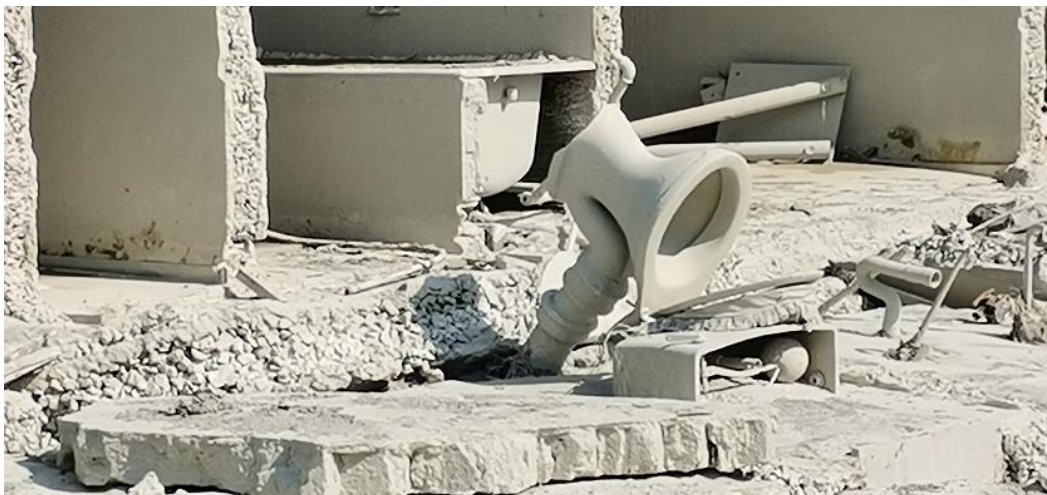
*Photo 7 Sewage infrastructure in some private homes and in the municipal infrastructure was swept away (Photo credit Brown Motsau and David van Wyk)*

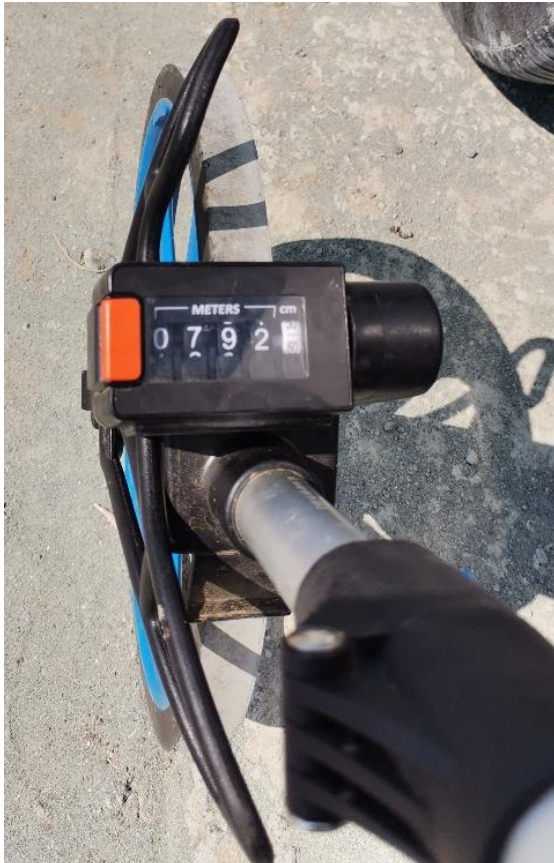
Photo 8 Slurry swept 792 m wide across the R704  
(Photo credit: Brown Motsau and David van Wyk)

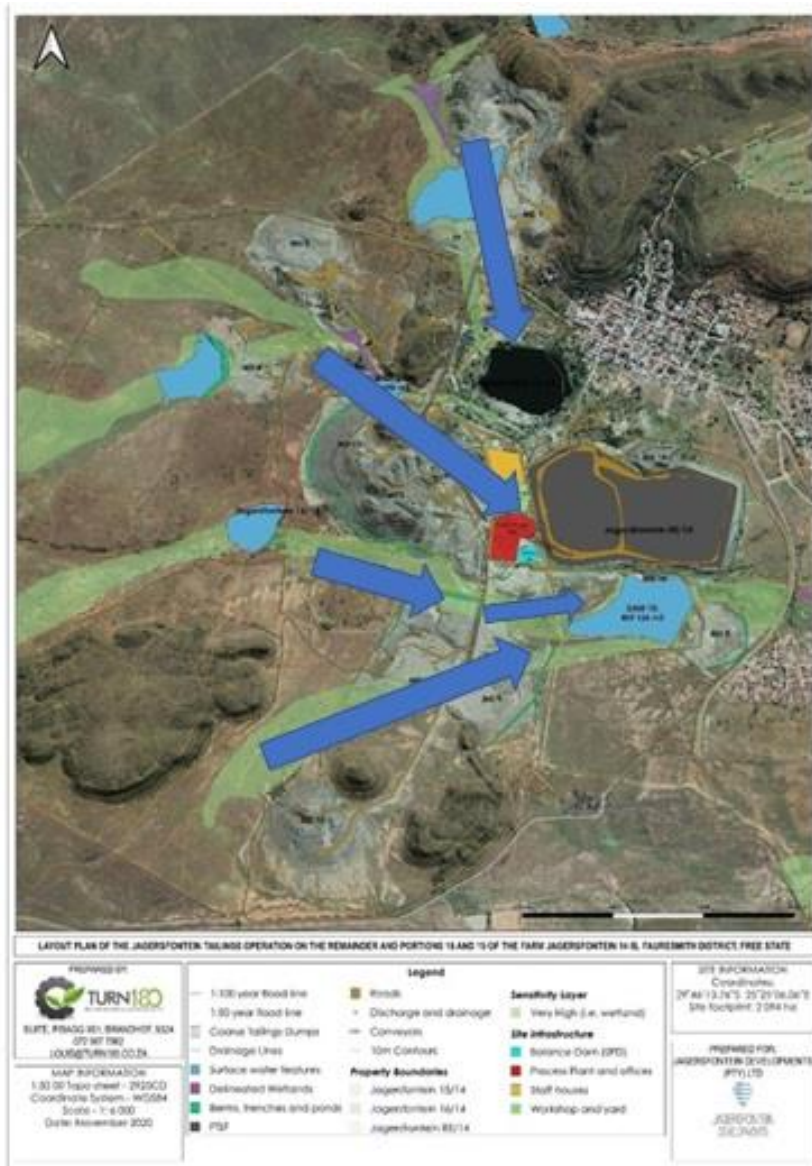
Figure 5 shows that the tailings dam was built on top of a shallow aquifer. Several catchments also flowed in directly behind the tailings, increasing its liquidity and the pressure on its northern wall above the communities of Charlesville and Itumeleng.

Figure 5 Blue arrows showing catchments flowing towards and converging exactly where the tailings are located (Turn 180)

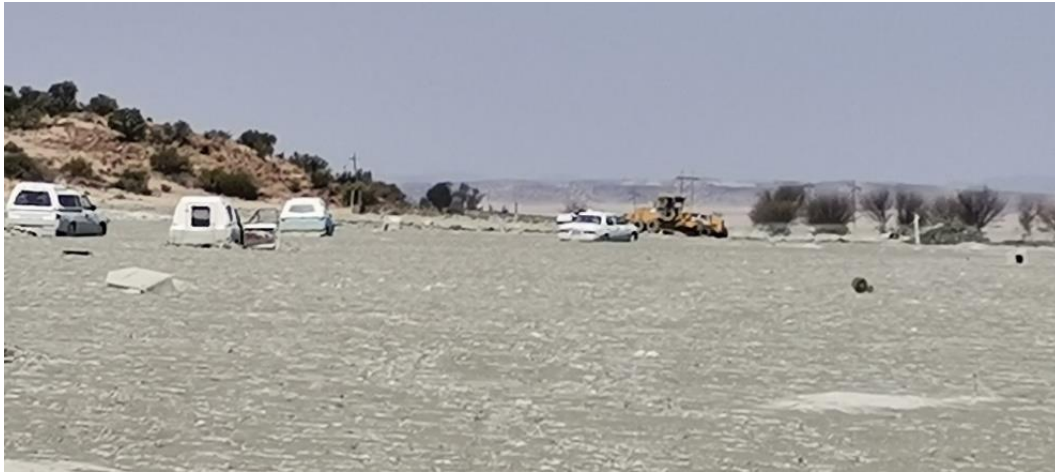
*Photo 9 Cars swept away by the tailings surge as it edged through Itumeleng  
(Photo credit Brown Motsau and David van Wyk)*

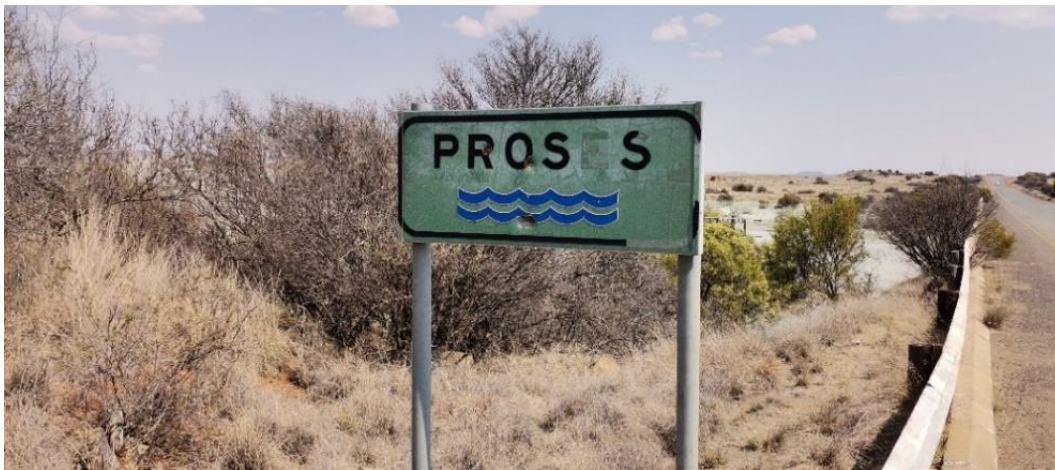
*Photo 10 Heavily impacted Proses River, some 10 km out of town  
(Photo credit Brown Motsau and David van Wyk)*

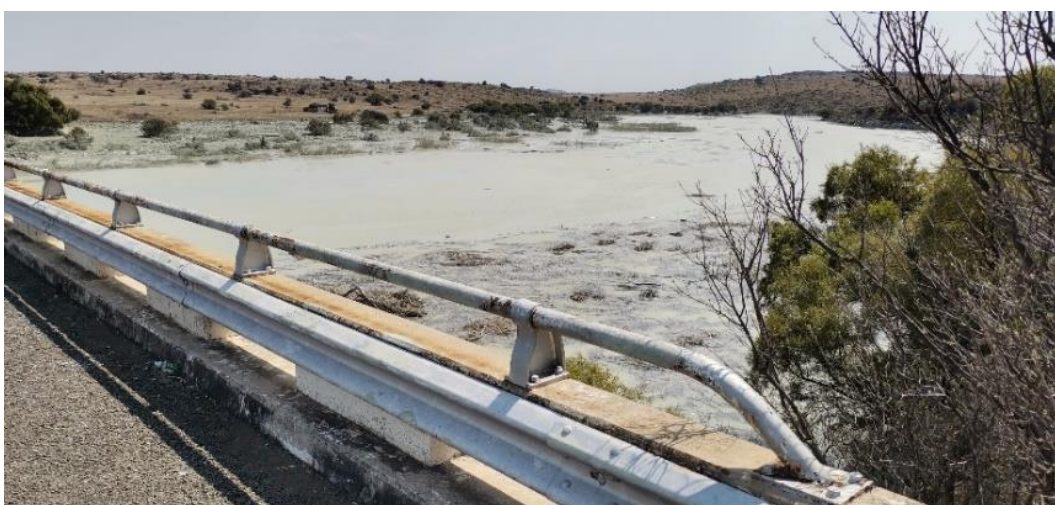
*Photo 11 Proses River, the fish leapt out onto the banks to escape the tailings mud  
(Photo Credit David van Wyk and Brown Motsau)*

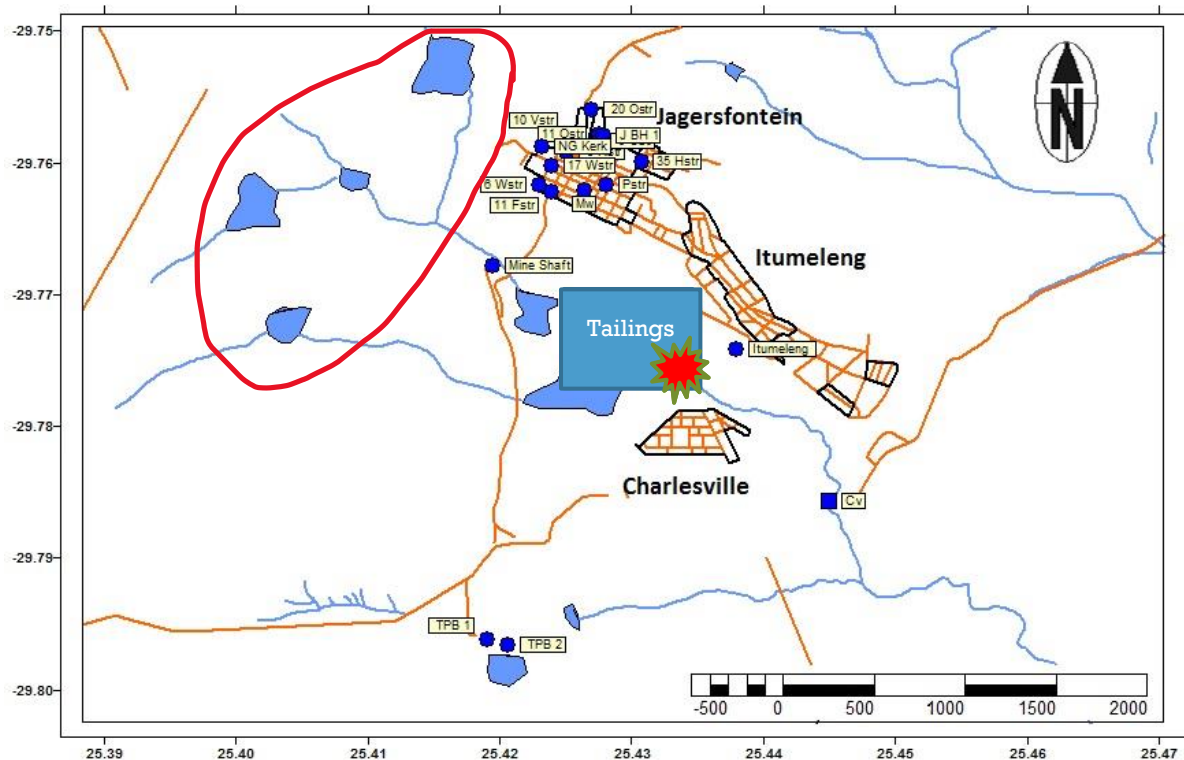
Figure 6 River catchments converged where the tailings is located.

*Note the upstream dams from the tailings indicating very poor planning, environmental impact assessment and environmental management plan by the mine, and absolute failure by the regulator (Adapted from Hoon, 2013)*
