# Report on the Jagersfontein Tailings Disaster

Updated Report - September 2023

## Executive Summary

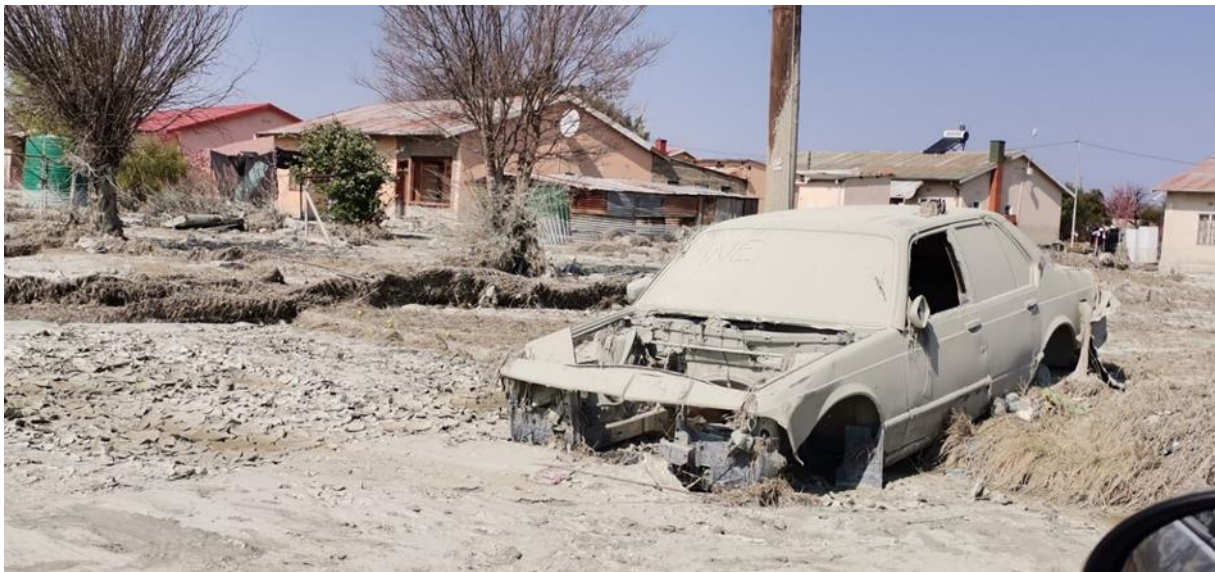
*Figure 1 Photo of the aftermath. Many of the low-income residents of Charlesville lost cars, furniture, homes, loved ones (Photo Brown Motsau and David van Wyk)*

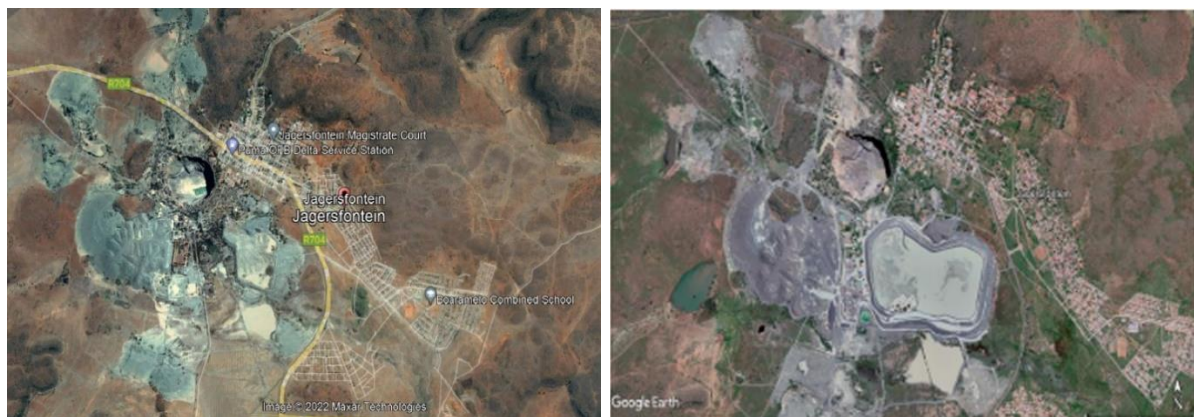
Figure 4 Photos of Jagersfontein tailings in 2005 and 2022 (Google Earth)

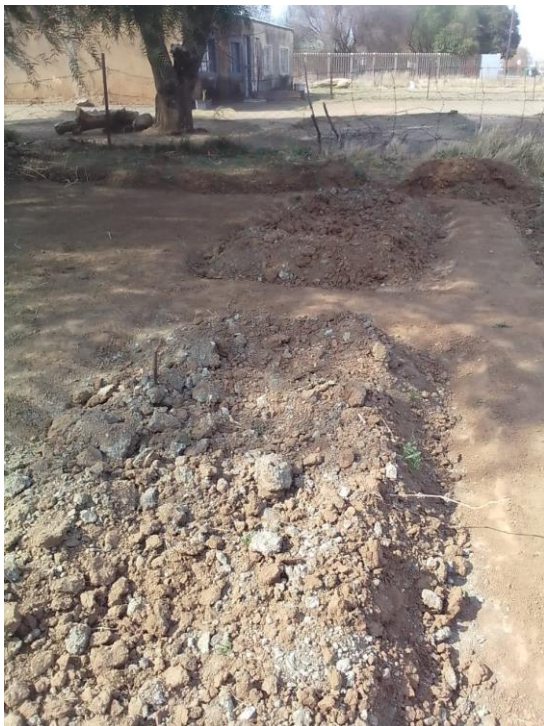
Another male resident, who lost 27 cows during the accident, recalls how he is now “less of a man”. After the accident, he has lost confidence and his wife now undermines him. He still tries his best to “show that he is still strong” by working in his gardens, but the gardens are contaminated with the poisonous sludge (see picture below).

*Figure 6 Garden soil contaminated with poisonous sludge*

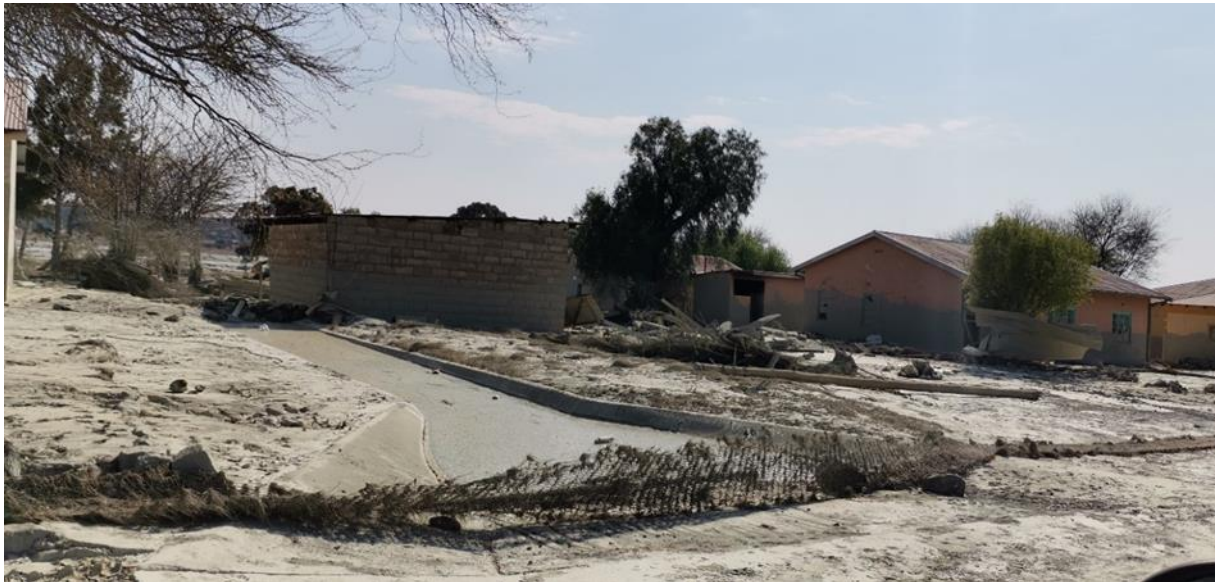
*Figure 7 The only thing left of these Charlesville houses in the front of the photo are their foundations (Photo Brown Motsau and David van Wyk)*

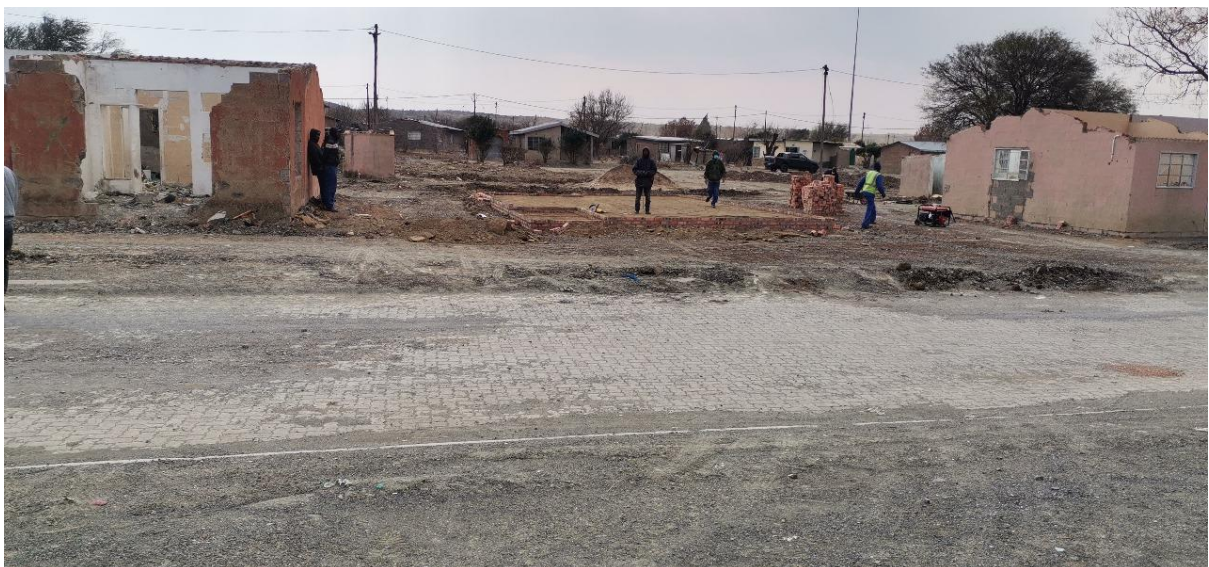
*Figure 8 A new house being built close to the ones that were damaged by the sludge*

The Bench Marks team visited the site where the mine is building new houses. The residents whose houses were swept away will have to settle for much smaller houses. This will be a difficult transition, but as the resident informed us: “there is nothing we can do. We have to adapt, even if adapting means settling for less.”

The smaller size of the replacement houses shows that there is no effort on the part of the mine to improve the lives of these communities. Furthermore, the tailings dam is still there, a reminder that there could be another accident in the future. The residents of these communities still live with the trauma that there could be another tailings dam accident.

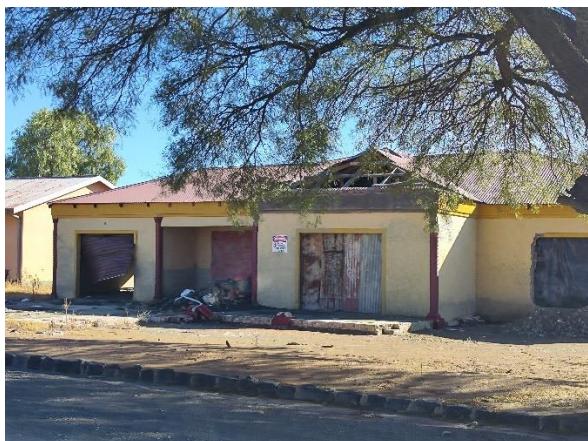
*Figure 9 A disaster-damaged house in the process of being repaired*

When the Bench Marks Research team visited the area on 31 July 2023, more than 10 months after the disaster, only three show houses had been constructed, while a number of disaster damaged

houses in Jagersfontein were in various stages of reconstruction. The Mayor's Office expressed dismay at the slow pace of housing construction, arguing that the temporary accommodation of displaced people must be costing millions.

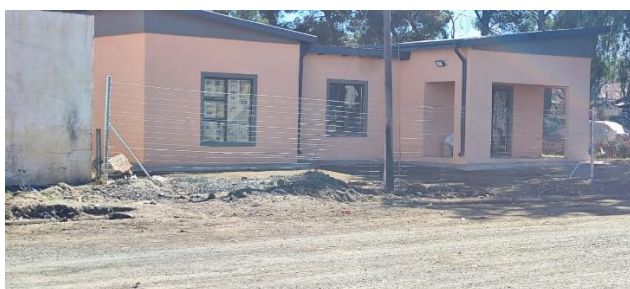
*Figure 10 One of 3 new houses constructed since the disaster a year ago*

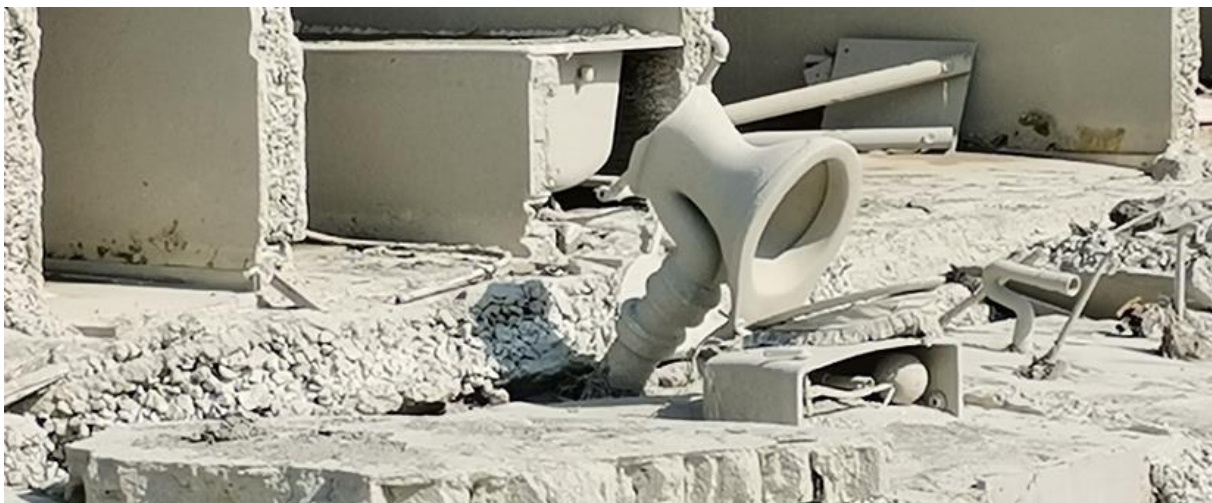
The flood of sludge also rendered the Jagersfontein wastewater treatment plant dysfunctional, and in a Bench Marks interview on 31 July 2023, the Kopanong Mayor expressed concern about the fact that the damage to the sewage system was so extensive that the entire sewage system was still not properly functional and would have to be replaced. The mayor noted continuous sewage spills, because of the disaster damage, and he commented that the local government could not financially cope. He feared an outbreak of cholera in the upcoming rain season should the issue of the sewage system not be addressed.

Figure 11 Sewage infrastructure in some private homes and in the municipality was swept away (Photo Brown Motsau and David van Wyk)

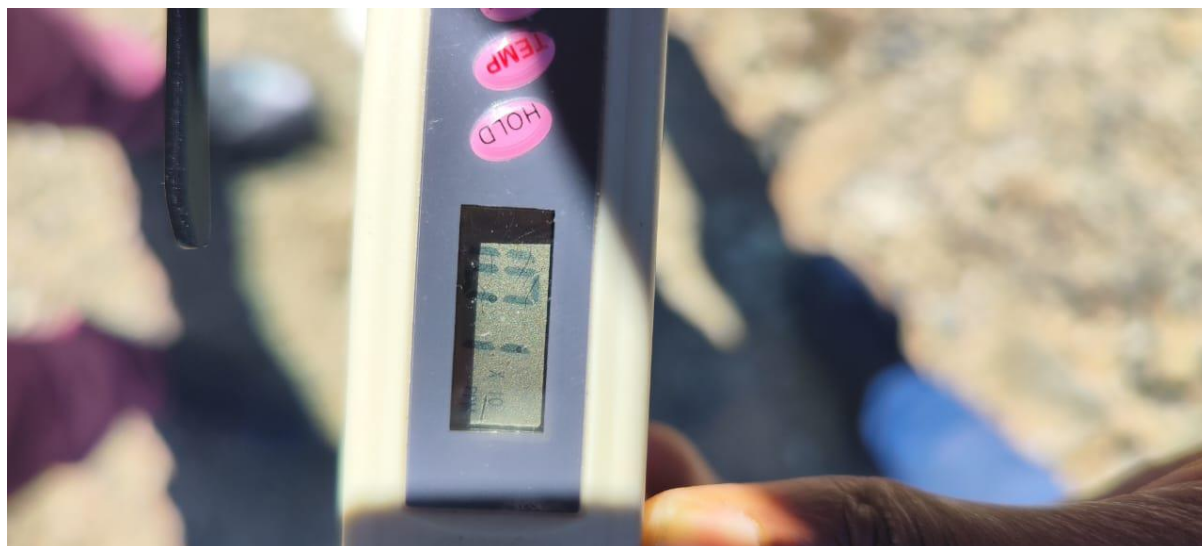
Bench Marks Foundation research team tested water in the stream below the tailings, finding the total dissolved solids levels to be incredibly high.

*Figure 12 Water seeping into the stream below the tailings gave a total dissolved solids reading of 1010 part per million. World Health Organisation safe levels for water have an upper limit of 500 part per million.*

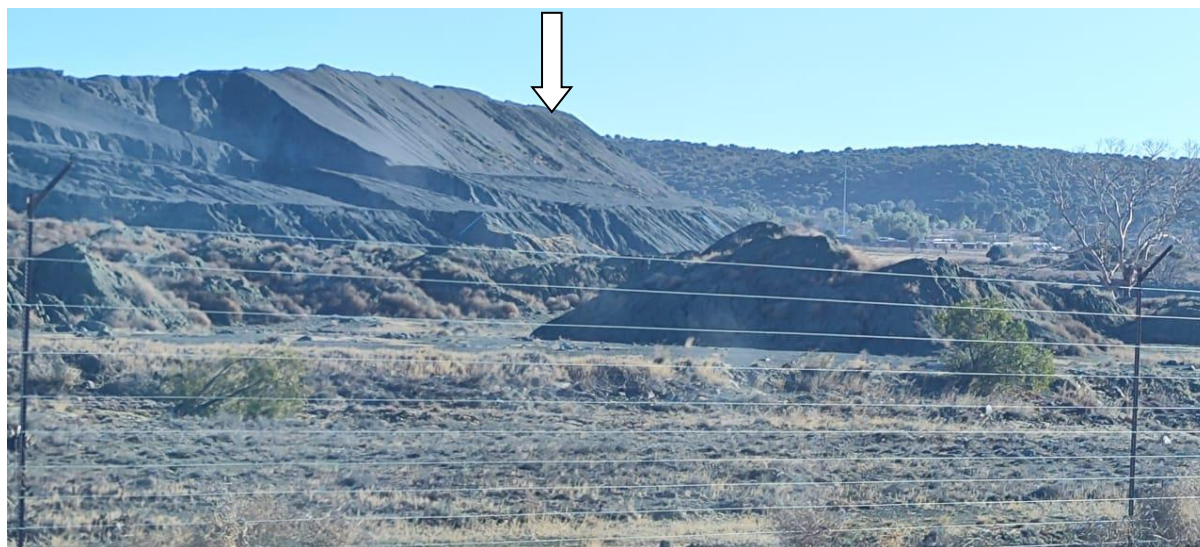
*Figure 18 The remaining corner of the Jagersfontein dam wall above Itumeleng*

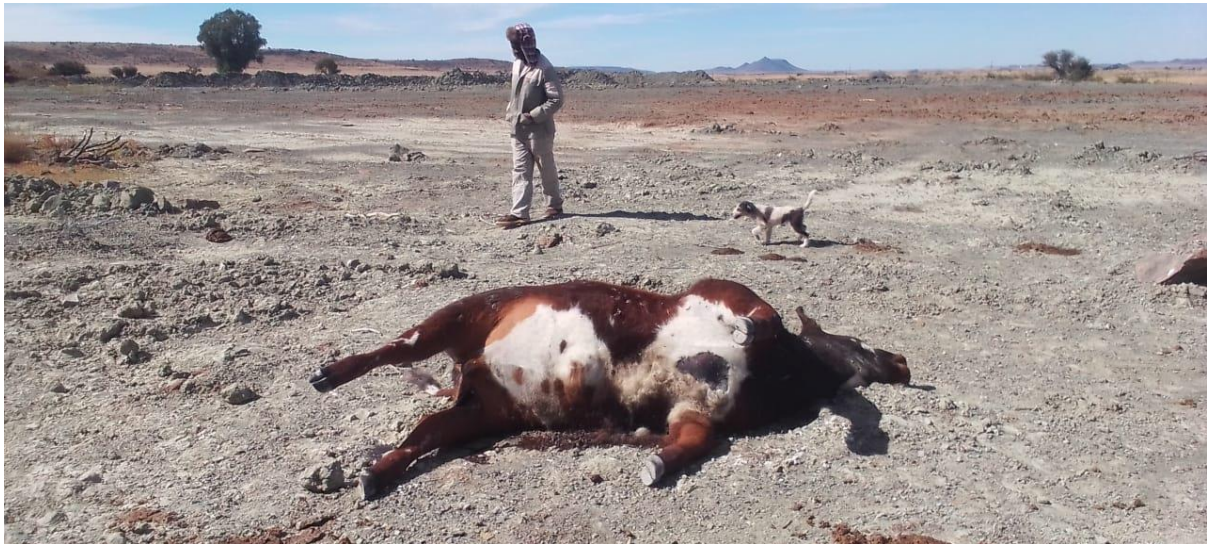
*Figure 19 Photo of dead cow on poisoned land*

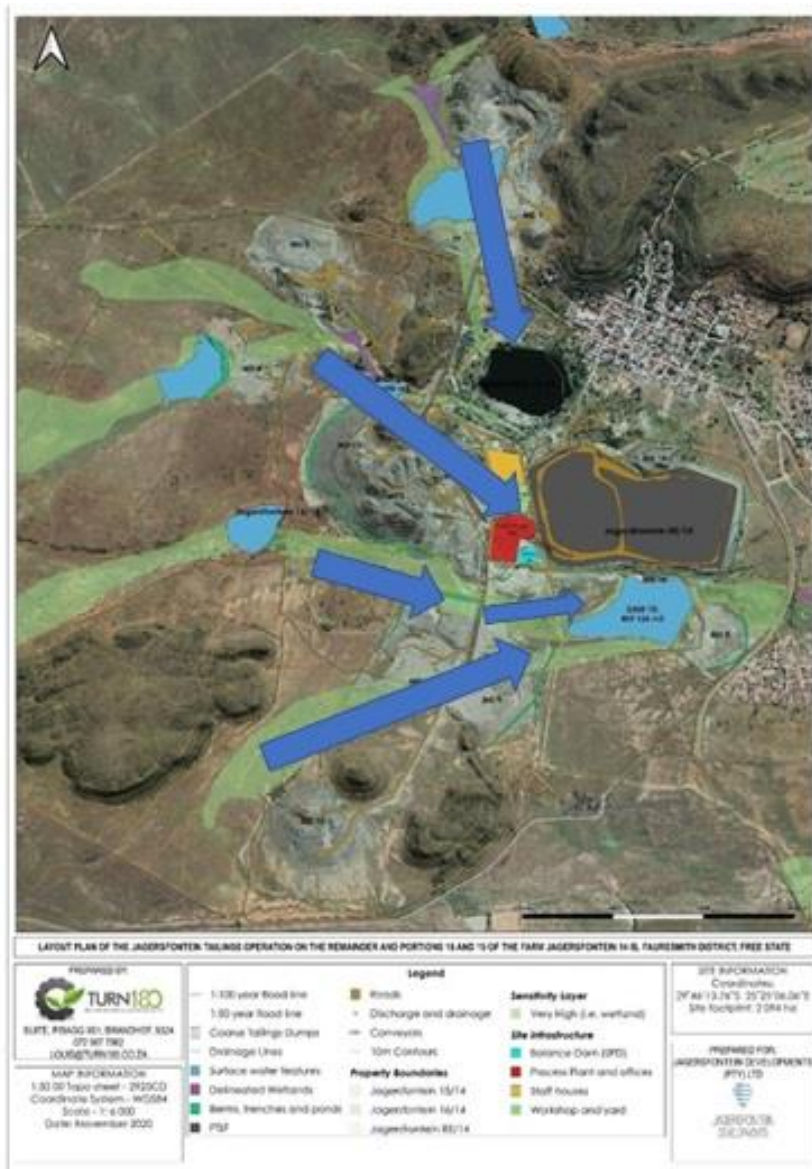
Figure 21 Location of tailings dam in relation to water catchments (blue arrows)

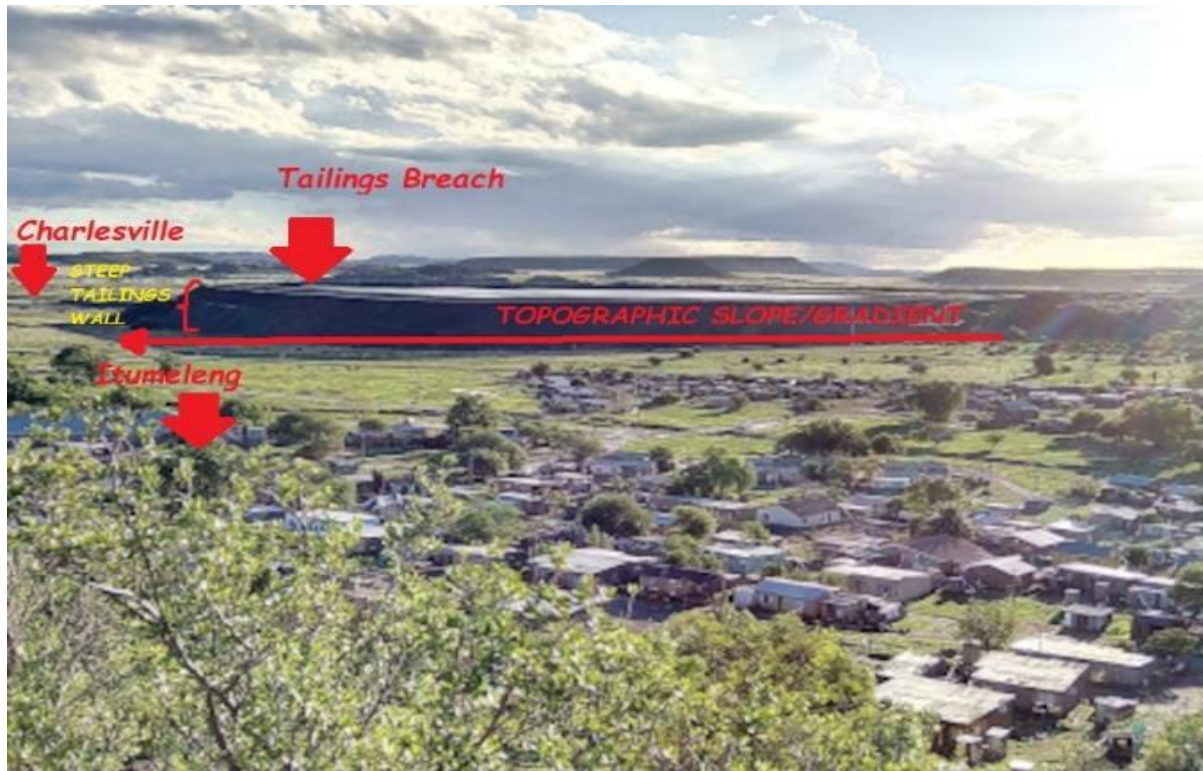
- 7) The dam was constructed on a slope with two township communities directly below it. Given its instability, the downward slope on which it stood increased the force of the surge once it collapsed, contributing to the destruction of property and infrastructure below it. Typical of apartheid urban planning and space allocation, the former white town of Jagersfontein was constructed above the mining operation and its tailings. It was the black townships of Itumeleng and Charlesville which were constructed downhill and downwind of the tailings, below the steepest gradients. This contributed to the devastating effect of the breach in the dam wall.

Figure 23 Annotated photograph showing the slope and gradient of the tailings and the location of the two townships (Adapted from Google Maps)

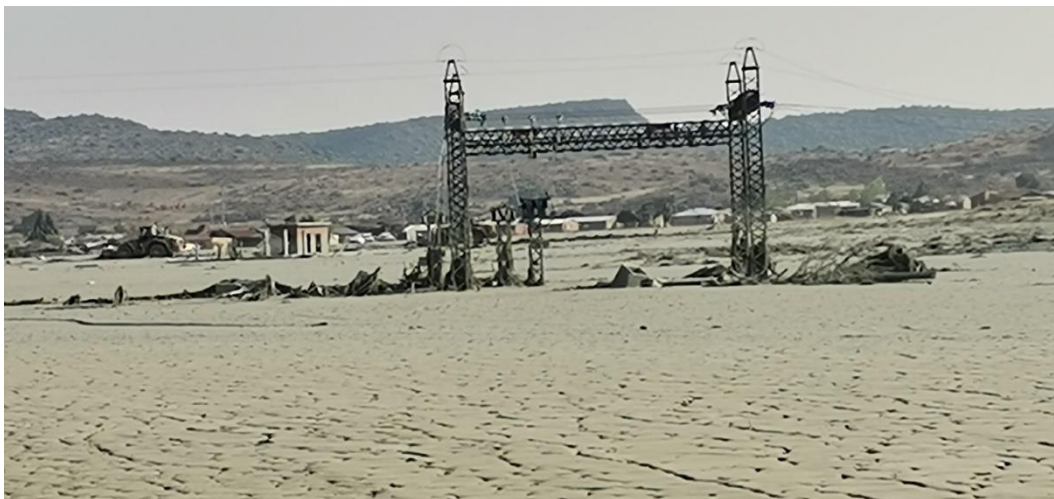
- 8) The proximity of the dam to critical infrastructure exacerbated the damage caused by the breach of the dam wall. When the tailings dam wall broke, the slurry swept away the electricity substation feeding the town, swamped the sewage works and halted water supply. It also swept across the R704 in three separate places.

Figure 24 Remains of the electricity substation of Jagersfontein (Photo credit David van Wyk and Brown Motsau)

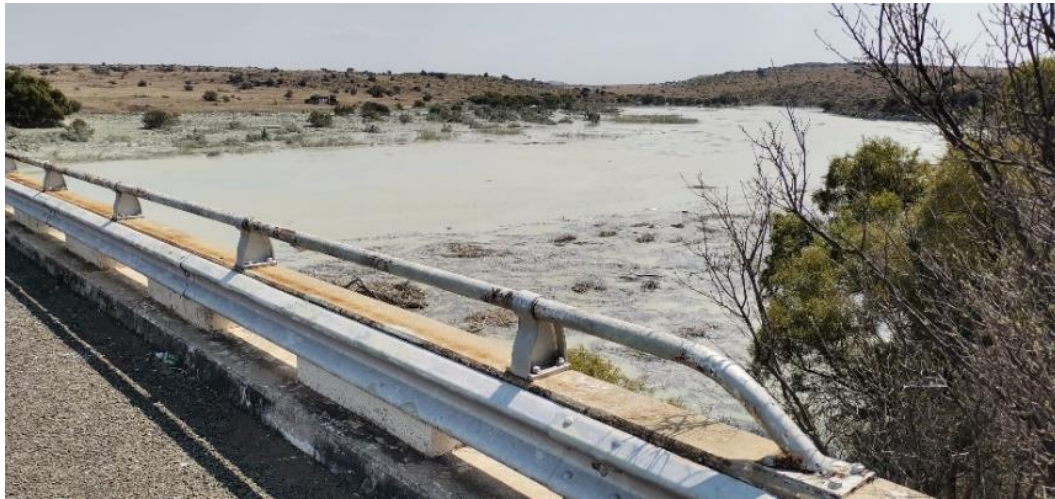
- 10) The location of the dam uphill from unpolluted surface water and groundwater caused additional damage to the environment. The surge ended up in the Proses River, ten kilometres downstream from Jagersfontein. The Proses River feeds into the Vaal River before it merges with the Xhariep River. Locals reported dead fish along the banks of the river.

*Figure 25 The Proses River. The fish leapt out onto the banks to escape the tailings mud. Photo credit David van Wyk and Brown Motsau*
