# Report on the Jagersfontein Tailings Disaster

BENCH MARKS FOUNDATION

Updated Report - September 2023

## Executive Summary

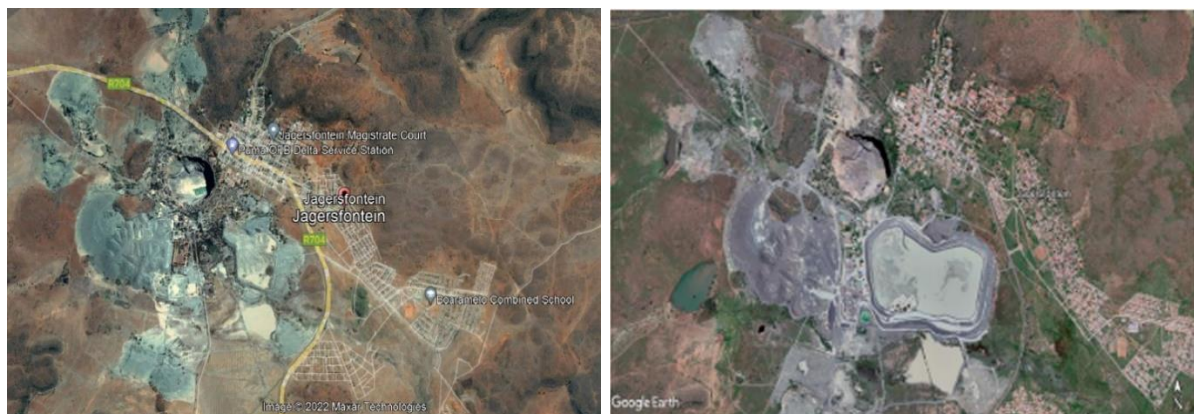
Figure 4 Photos of Jagersfontein tailings in 2005 and 2022 (Google Earth)

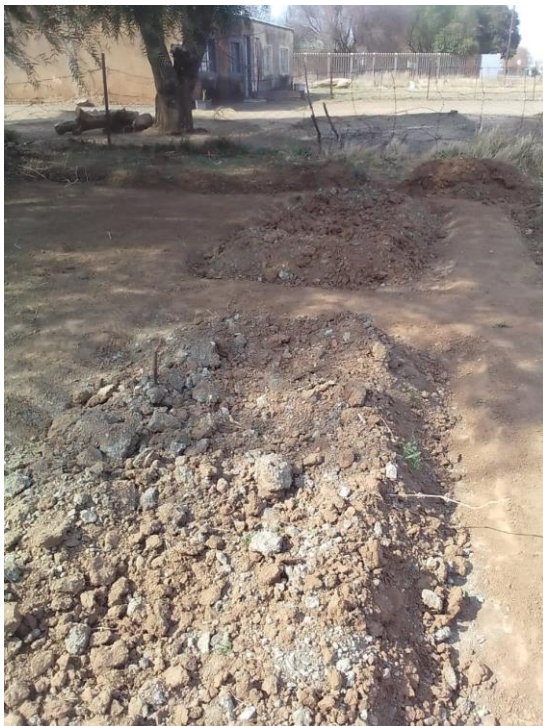
Another male resident, who lost 27 cows during the accident, recalls how he is now “less of a man”. After the accident, he has lost confidence and his wife now undermines him. He still tries his best to “show that he is still strong” by working in his gardens, but the gardens are contaminated with the poisonous sludge (see picture below).

*Figure 6 Garden soil contaminated with poisonous sludge*

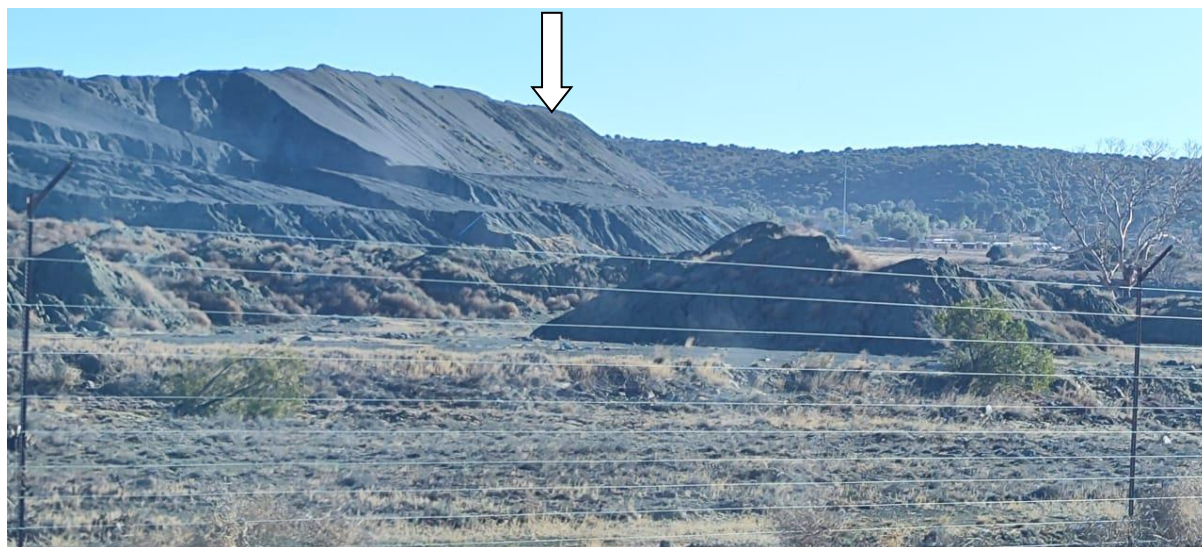
*Figure 18 The remaining corner of the Jagersfontein dam wall above Itumeleng*
