# Report on the Jagersfontein Tailings Disaster

Bench Marks Foundation  
October 2022

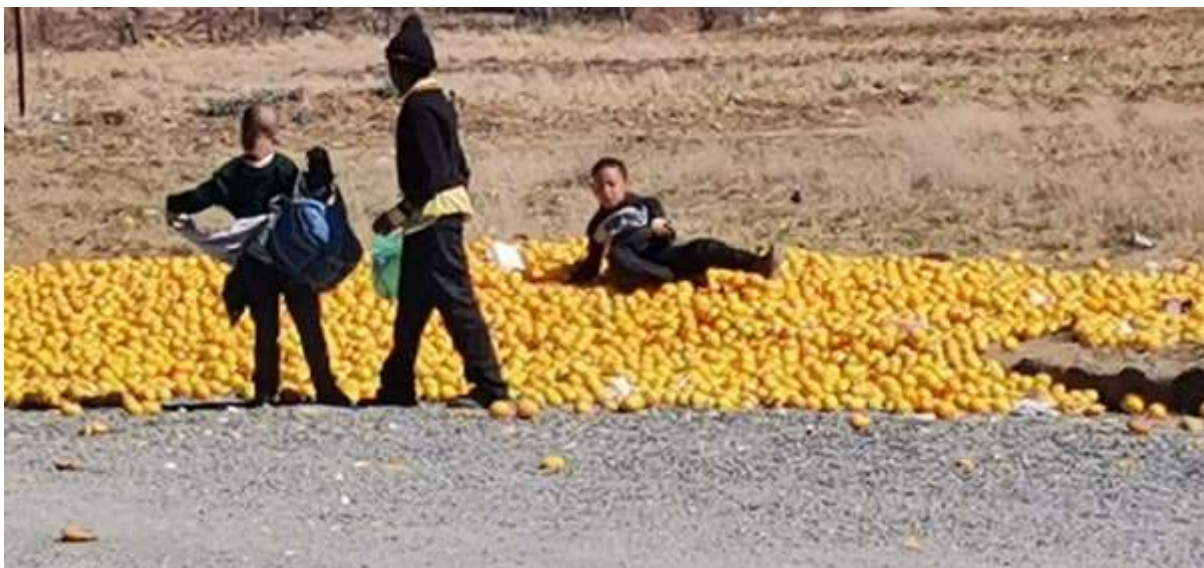
Some days after the disaster, a truck arrived daily and dumped a load of oranges on the pavement next to the road in Charlesville, with no attempt to package or distribute the oranges in an orderly manner. The researchers also found no evidence of food parcels distributed in the community. Community members expressed their disgust at this, “These oranges are from Johan Rupert’s orchards”. claimed an old female pensioner, “these people have no respect for us, they throw food on the floor as if we are animals”.

*Photo 12 Oranges dumped on the pavement of Charlesville (Photo credit David van Wyk)*

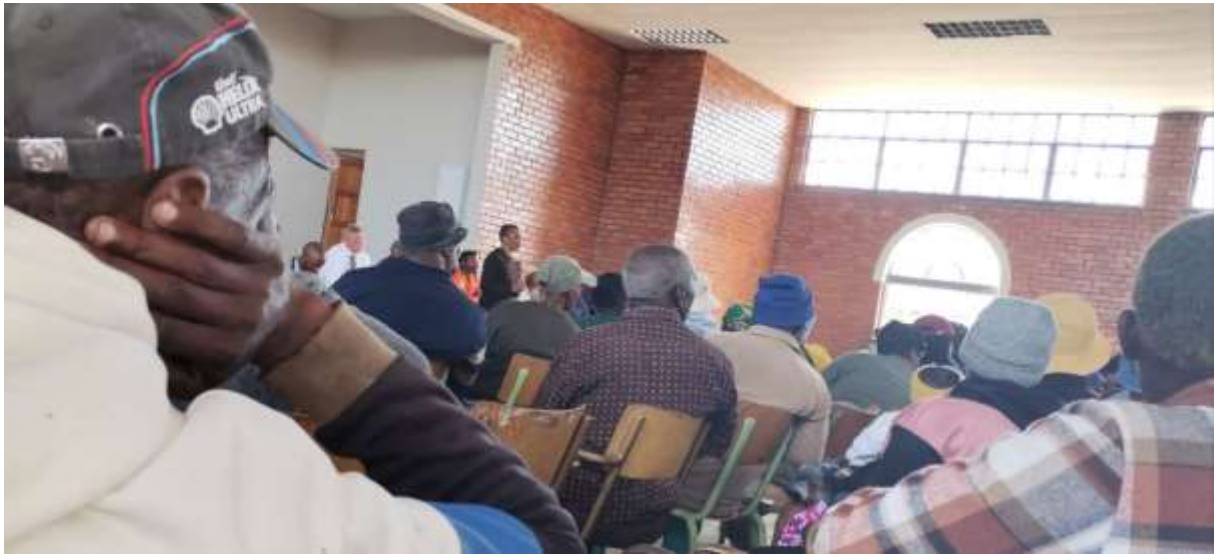
The Mayor of Kopanong, Mr Xolani Tseletsele, in conversations with the researchers, expressed his frustration about all the meetings he has had to attend. “Now is not the time for meetings, now is the time for repair, reconstruction and development”, he said. He was also concerned about the lack of response and engagement from the mining company with the affected communities. He was also concerned that mining was a national competency and that there was little that local and provincial government could do to call mining companies to account. However, the environmental mess left behind are local and provincial competencies. This is perhaps why mining companies so glibly abandon mines or fail to comply with regulations and laws relating to pollution and the destruction of the environment.

*Photo 13 Mayoral meeting in Itumeleng following the disaster (Photo credit David van Wyk)*
