# Report on the Jagersfontein Tailings Disaster

Research Department

Bench Marks Foundation  
October 2022

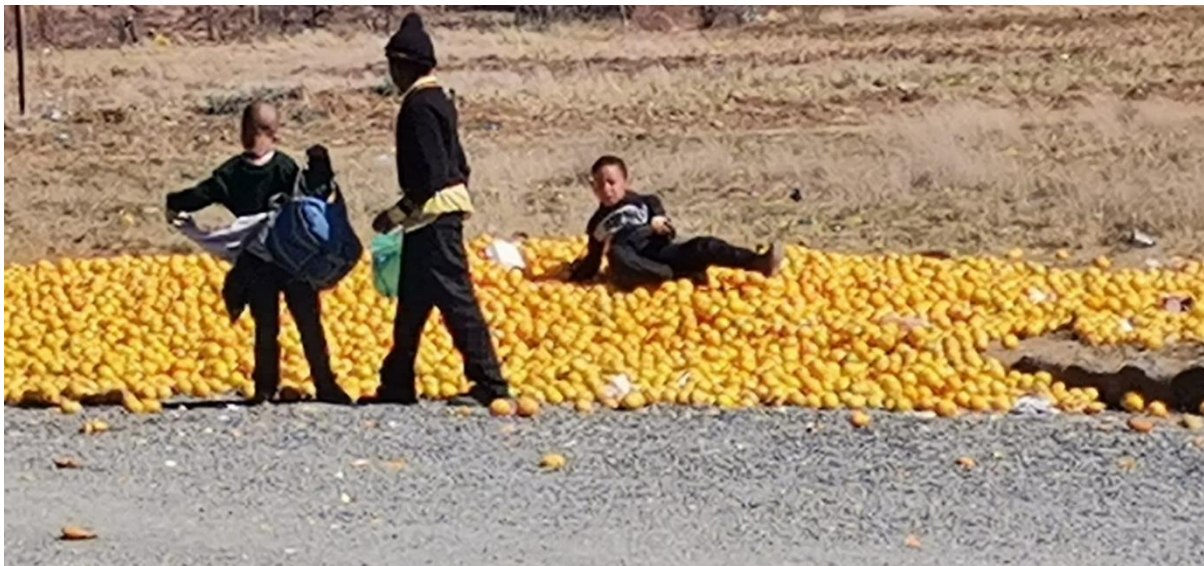
Some days after the disaster, a truck arrived daily and dumped a load of oranges on the pavement next to the road in Charlesville, with no attempt to package or distribute the oranges in an orderly manner. The researchers also found no evidence of food parcels distributed in the community. Community members expressed their disgust at this, “These oranges are from Johan Rupert’s orchards”. claimed an old female pensioner, “these people have no respect for us, they throw food on the floor as if we are animals”.

*Photo 12 Oranges dumped on the pavement of Charlesville (Photo credit David van Wyk)*

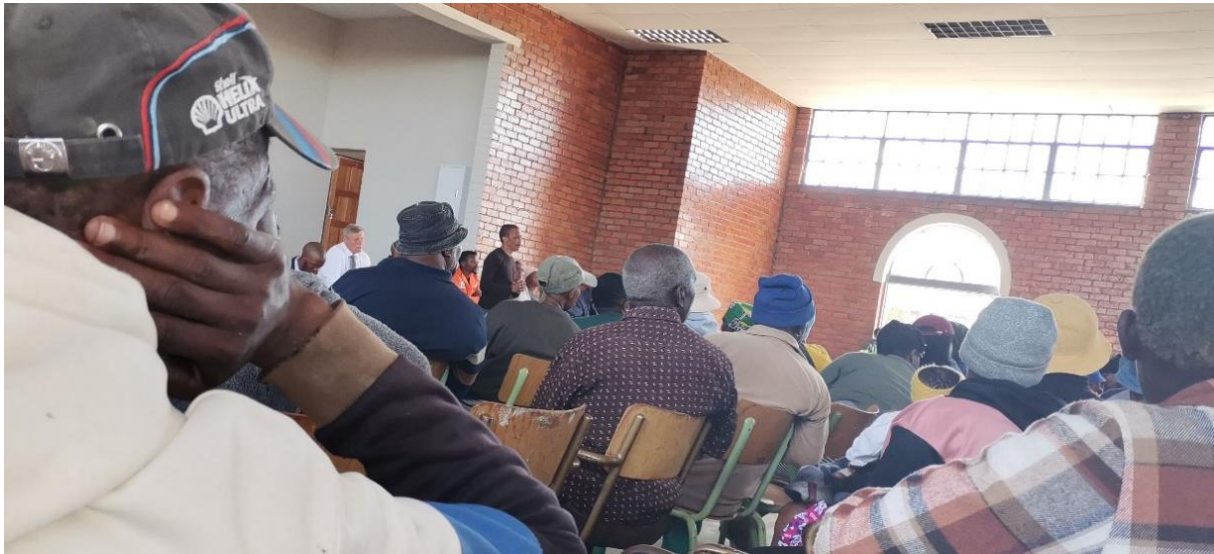
The Mayor of Kopanong, Mr Xolani Tseletsele, in conversations with the researchers, expressed his frustration about all the meetings he has had to attend. “Now is not the time for meetings, now is the time for repair, reconstruction and development”, he said. He was also concerned about the lack of response and engagement from the mining company with the affected communities. He was also concerned that mining was a national competency and that there was little that local and provincial government could do to call mining companies to account. However, the environmental mess left behind are local and provincial competencies. This is perhaps why mining companies so glibly abandon mines or fail to comply with regulations and laws relating to pollution and the destruction of the environment.

*Photo 13 Mayoral meeting in Itumeleng following the disaster (Photo credit David van Wyk)*
